Issue No. : 1
Issue Date : July 2010
Project No. : 768

**JOINT USER COMPLEX AND
WHOLESALE FISH MARKET AT
AREA 44, TUEN MUN**

**ENVIRONMENTAL MONITORING &
AUDIT REPORT (JUNE 2010)**

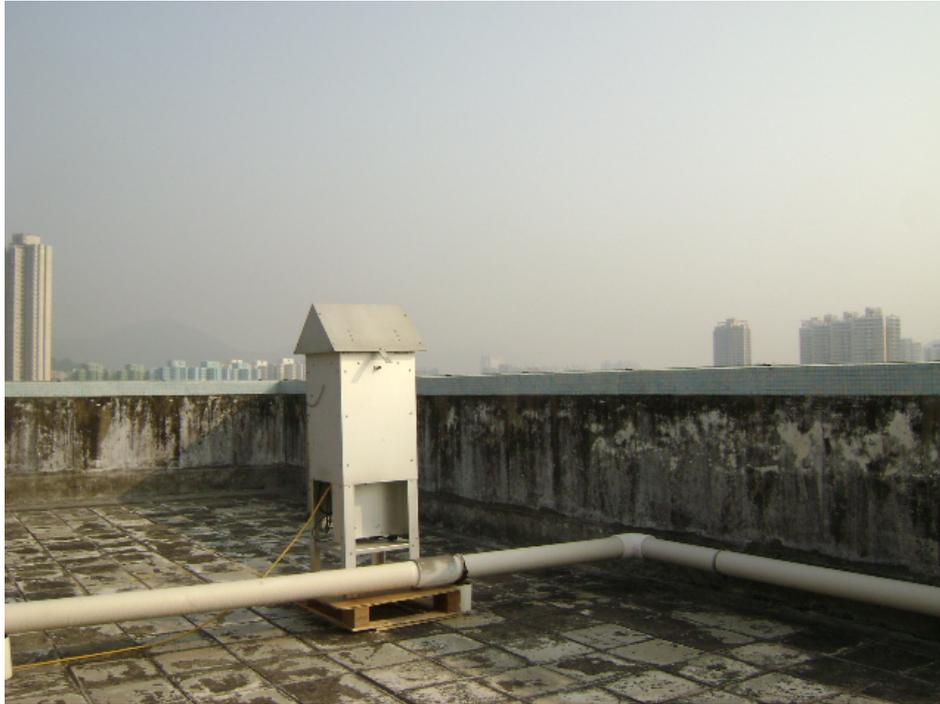
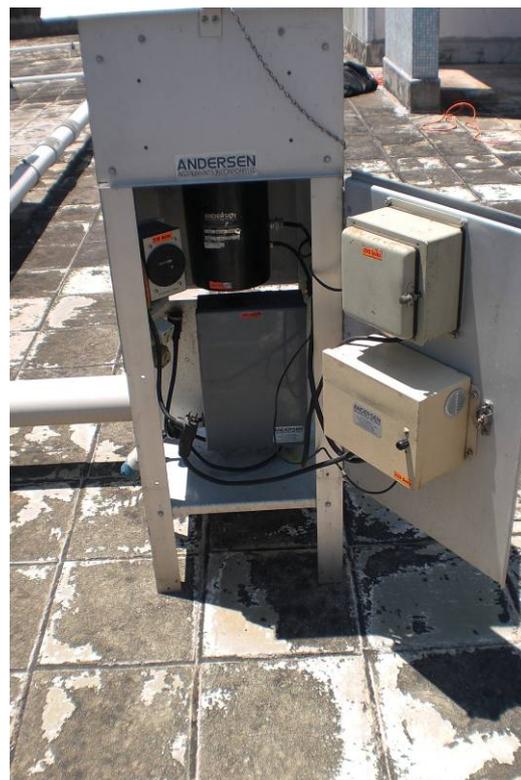
4

Roof top of Block 15, Yuet Wu Villa

High-Volume Dust Sampler

**JOINT USER COMPLEX AND WHOLESALE FISH MARKET AT AREA 44,
TUEN MUN
PHOTOS OF AIR QUALITY MONITORING STATION**

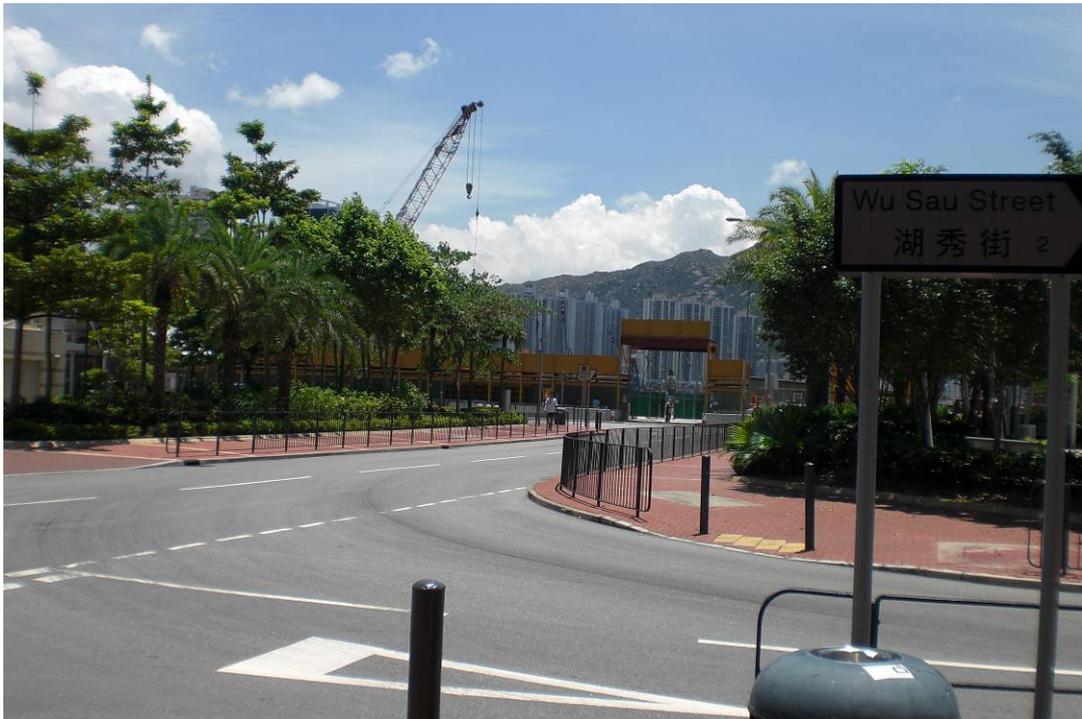
5

Noise monitoring station

View from the noise monitoring station

**JOINT USER COMPLEX AND WHOLESALE FISH MARKET AT AREA 44,
TUEN MUN
PHOTOS OF NOISE MONITORING STATION**
