**JOINT USER COMPLEX AND
WHOLESALE FISH MARKET AT AREA
44, TUEN MUN**

**ENVIRONMENTAL MONITORING &
AUDIT REPORT (AUGUST 2008)**

ALLIED ENVIRONMENTAL CONSULTANTS LTD.

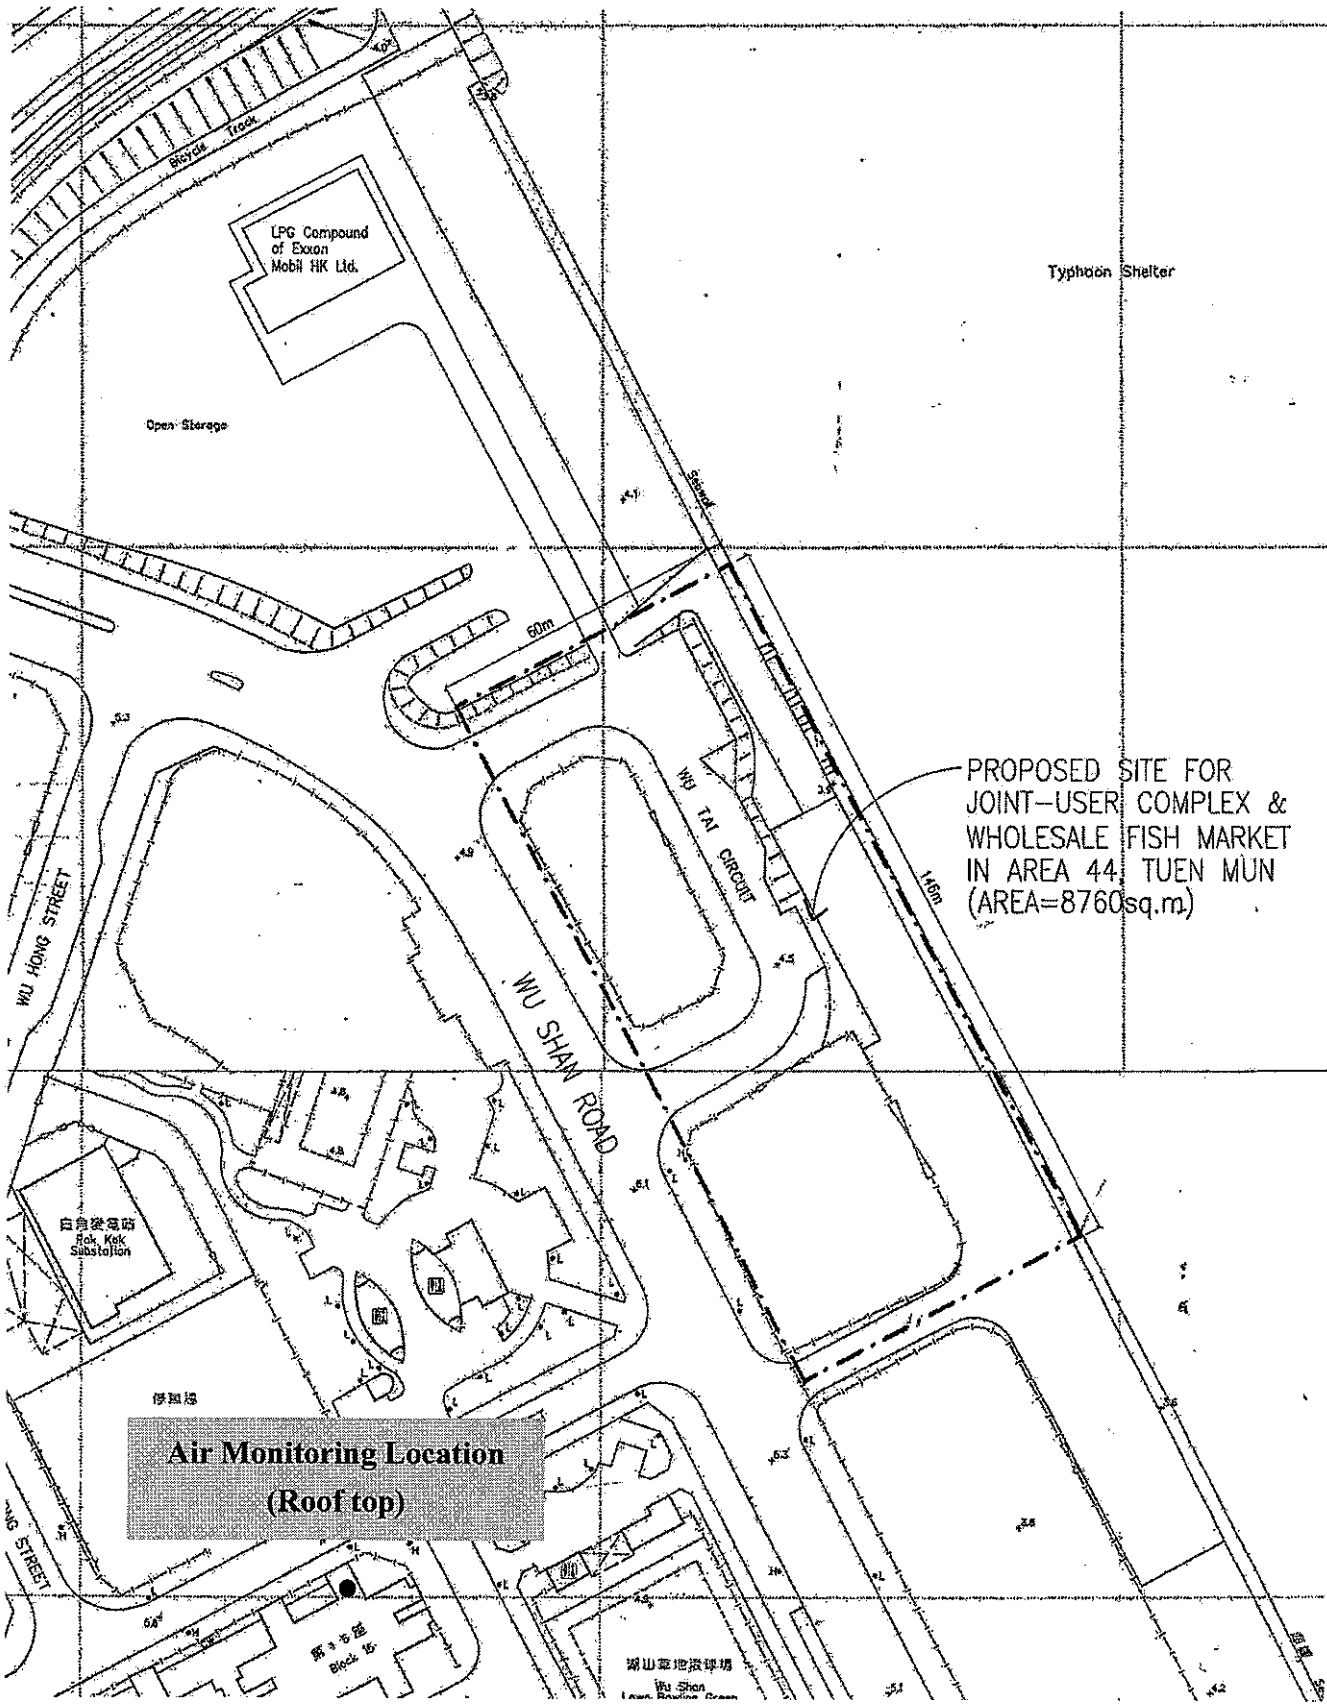
Figure No.	Rev:
2	0
Scale	Date
NTS	08/08

Air quality monitoring and noise monitoring were conducted at Block 15, Yuet Wu Villa on on 1st, 7th, 13th, 19th, 25th and 30th August 2008. Air quality monitoring station was set up at the roof top of the residential block and noise monitoring was conducted at 1.2m above ground level at the junction of Wu Sau Street and Wu On Street as given in Figure 2 and 3. Figure 4 and 5 show photos taken during monitoring at the two locations.

LOCATION OF AIR QUALITY MONITORING STATION

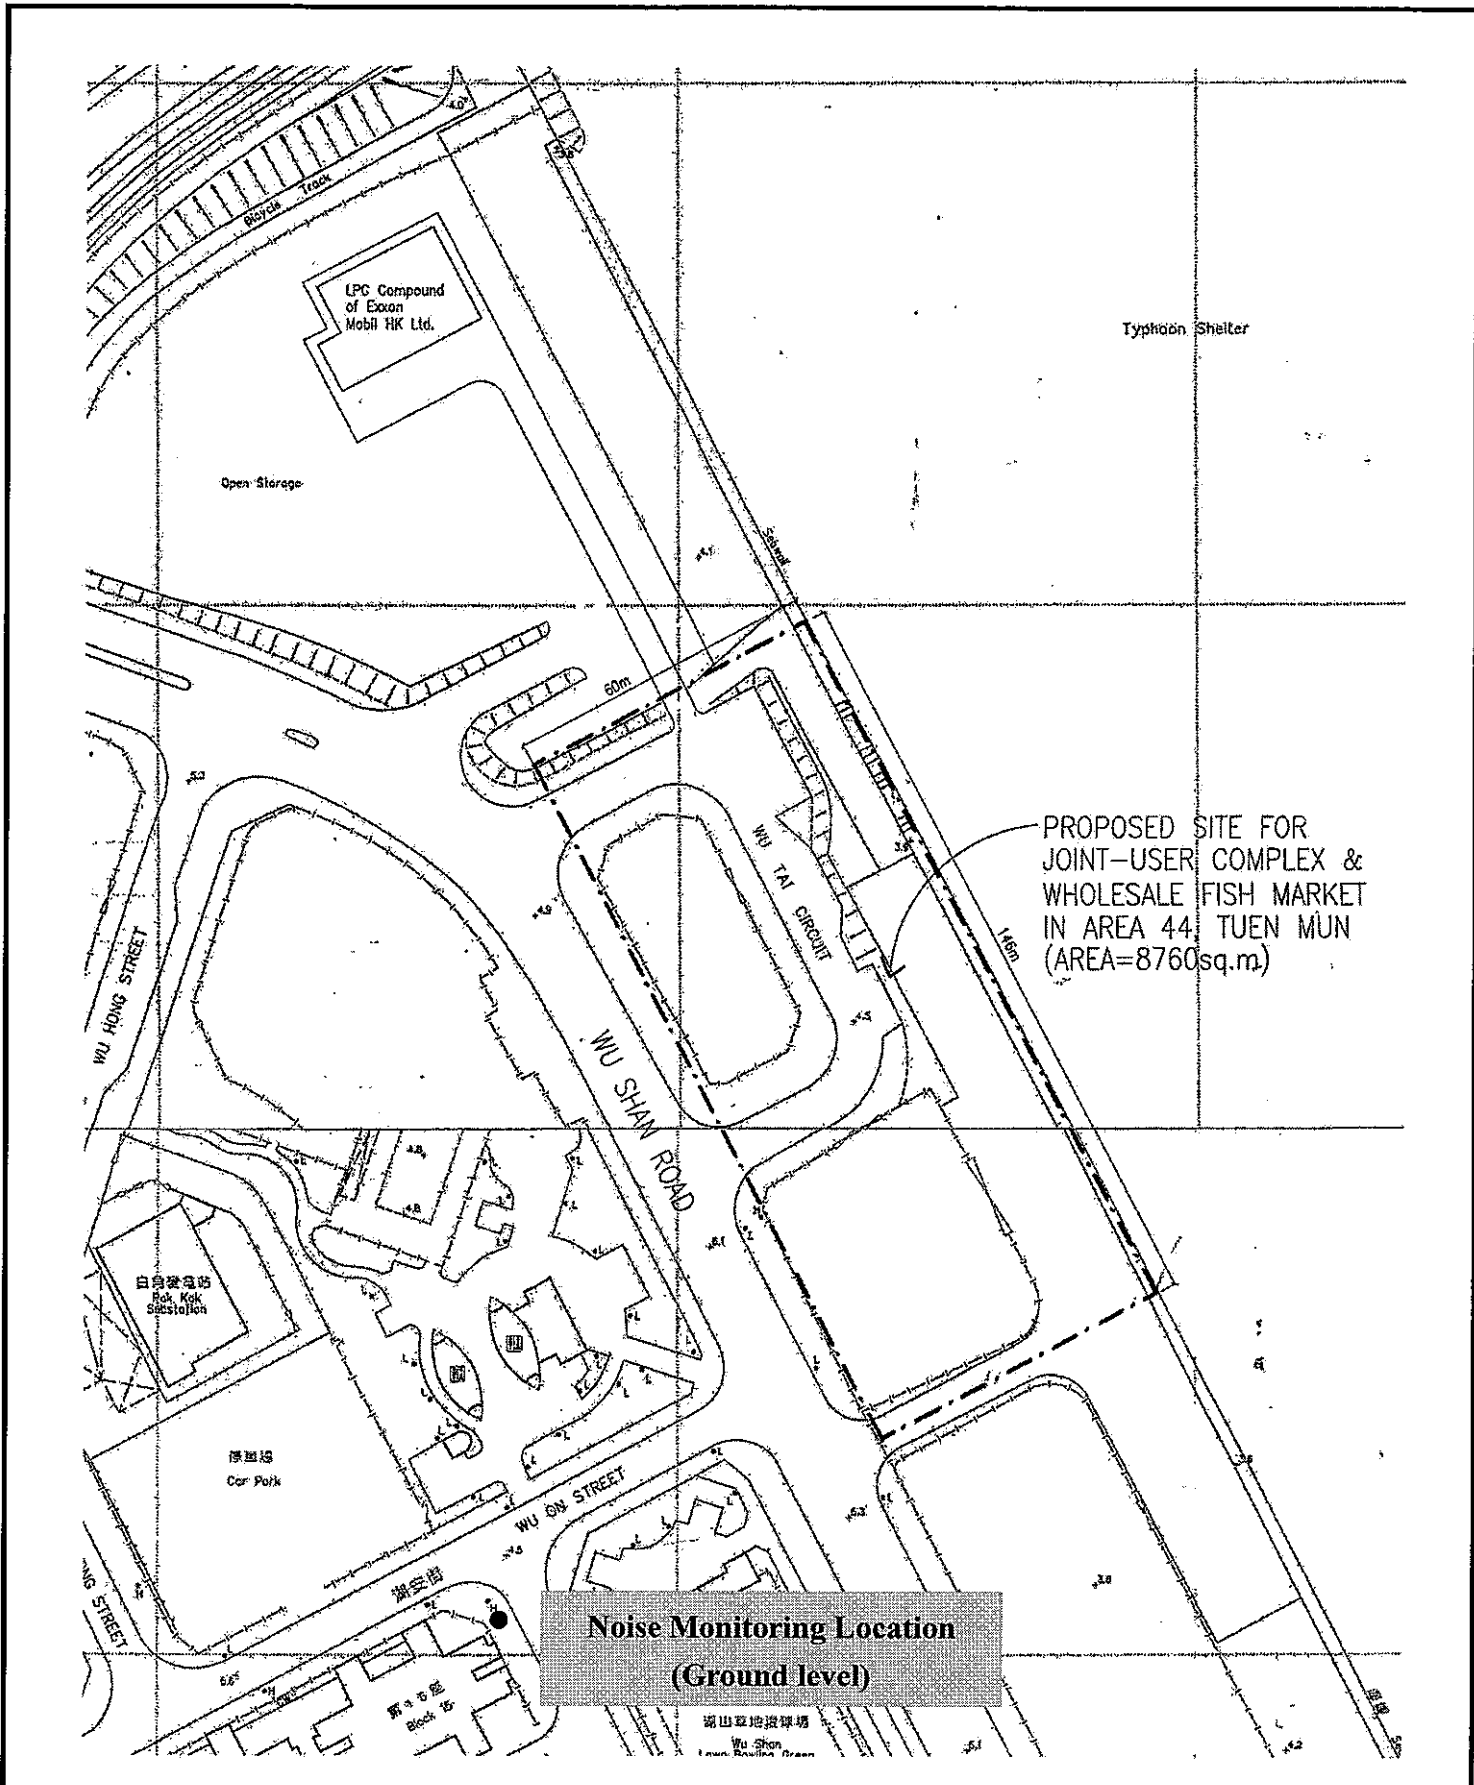
Figure No.	Rev.:
3	0
Scale	Date
NTS	08/08

**JOINT USER COMPLEX AND WHOLESALE FISH MARKET AT AREA 44,
TUEN MUN
LOCATION OF NOISE MONITORING STATION**

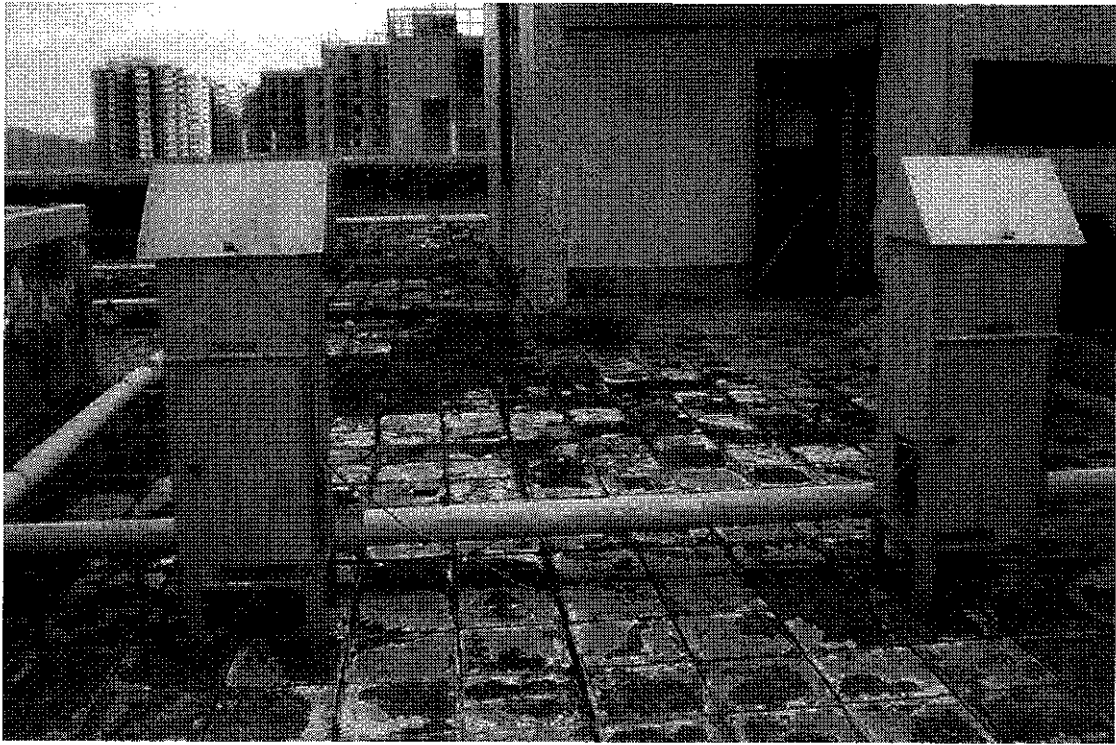
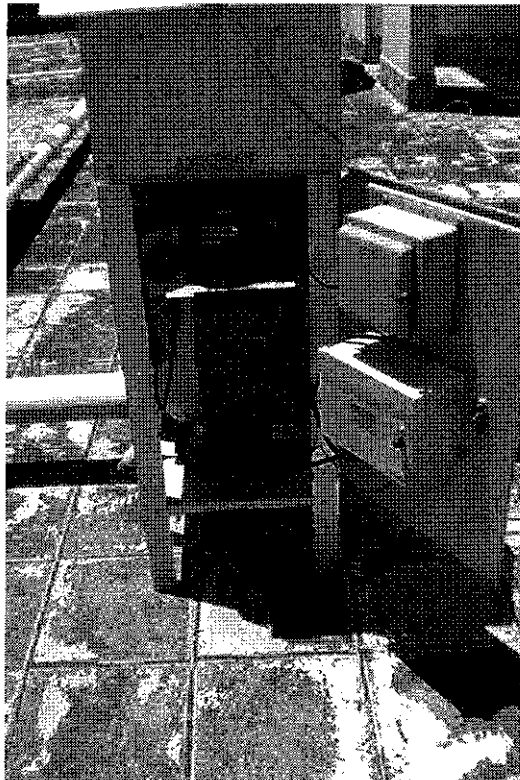
Figure No.	Rev.:
4	0
Scale	Date
NTS	08/08

1-hour and 24-hour TSP air quality monitoring was conducted at the designated air quality monitoring location using a High Volume TSP Sampler (Model No: Anderson GMWS-2310 ACCU-VOL) at the designated location. The Calibration Record of the High-Volume TSP

Roof top of Block 15, Yuet Wu Villa

High-Volume Dust Sampler

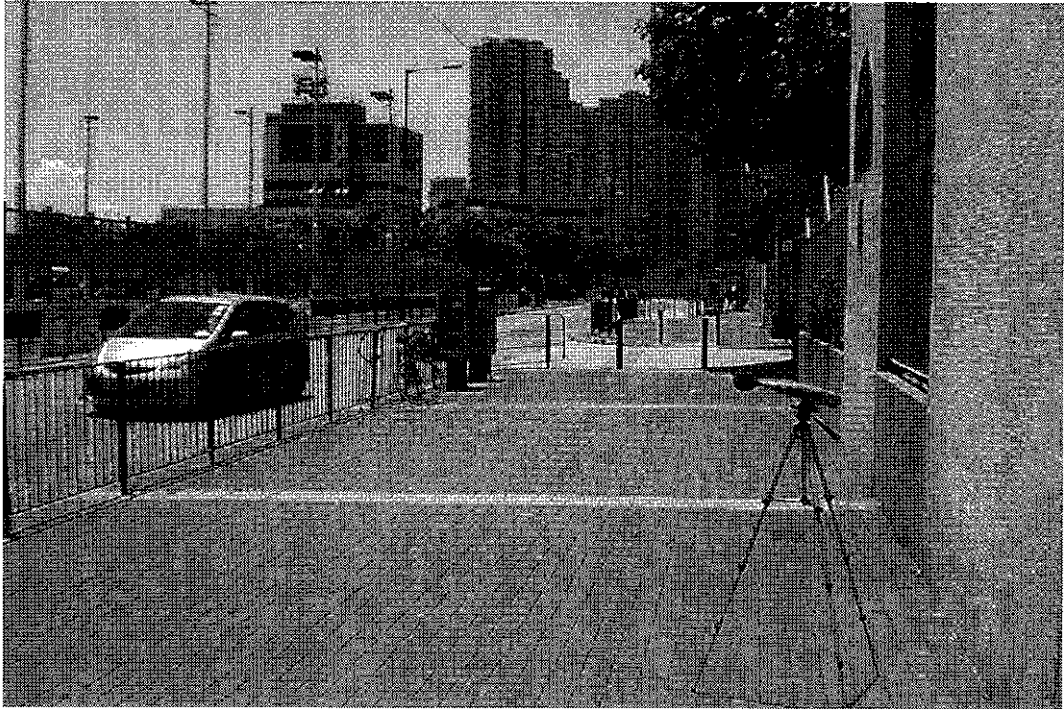
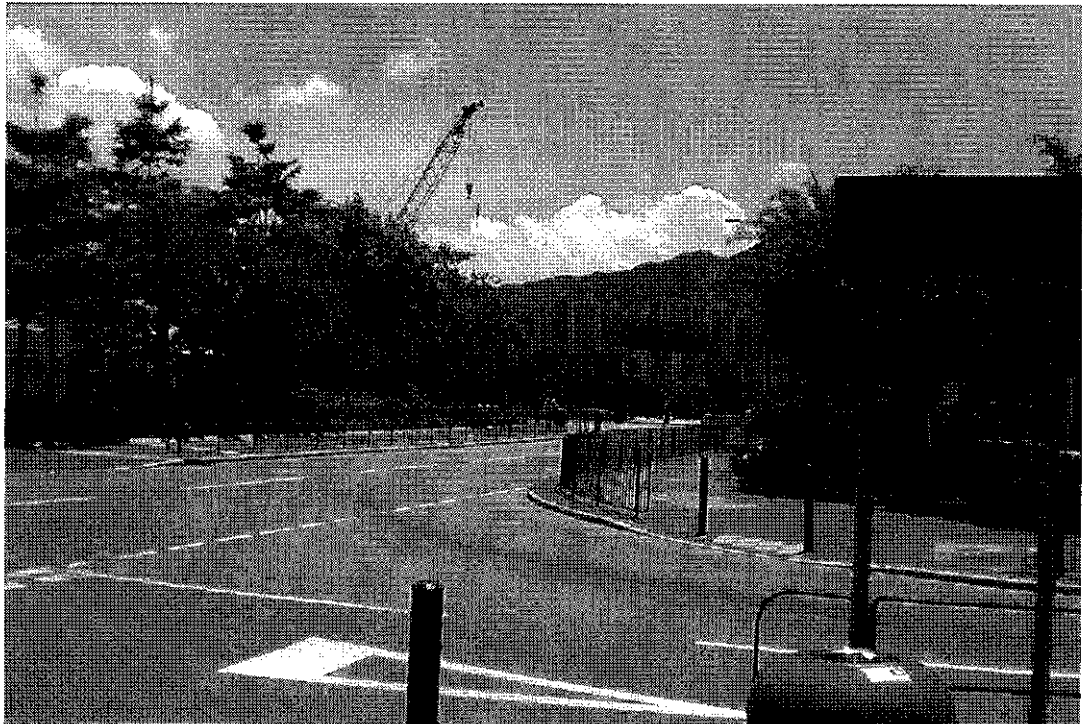
Figure No.	Rev.:
5	0
Scale	Date
NTS	08/08

Noise levels measurements were recorded in terms of thirty minutes A-weighted equivalent continuous sound pressure level ($L_{eq}(30min)$) on a weekly basis. The sound level meter was calibrated immediately prior to and following each noise measurement. The meter was mounted on a tripod at a height of 1.2m and the microphone was positioned at 1m away the building façade of the noise monitoring station facing the construction site.

Noise monitoring station

View from the noise monitoring station

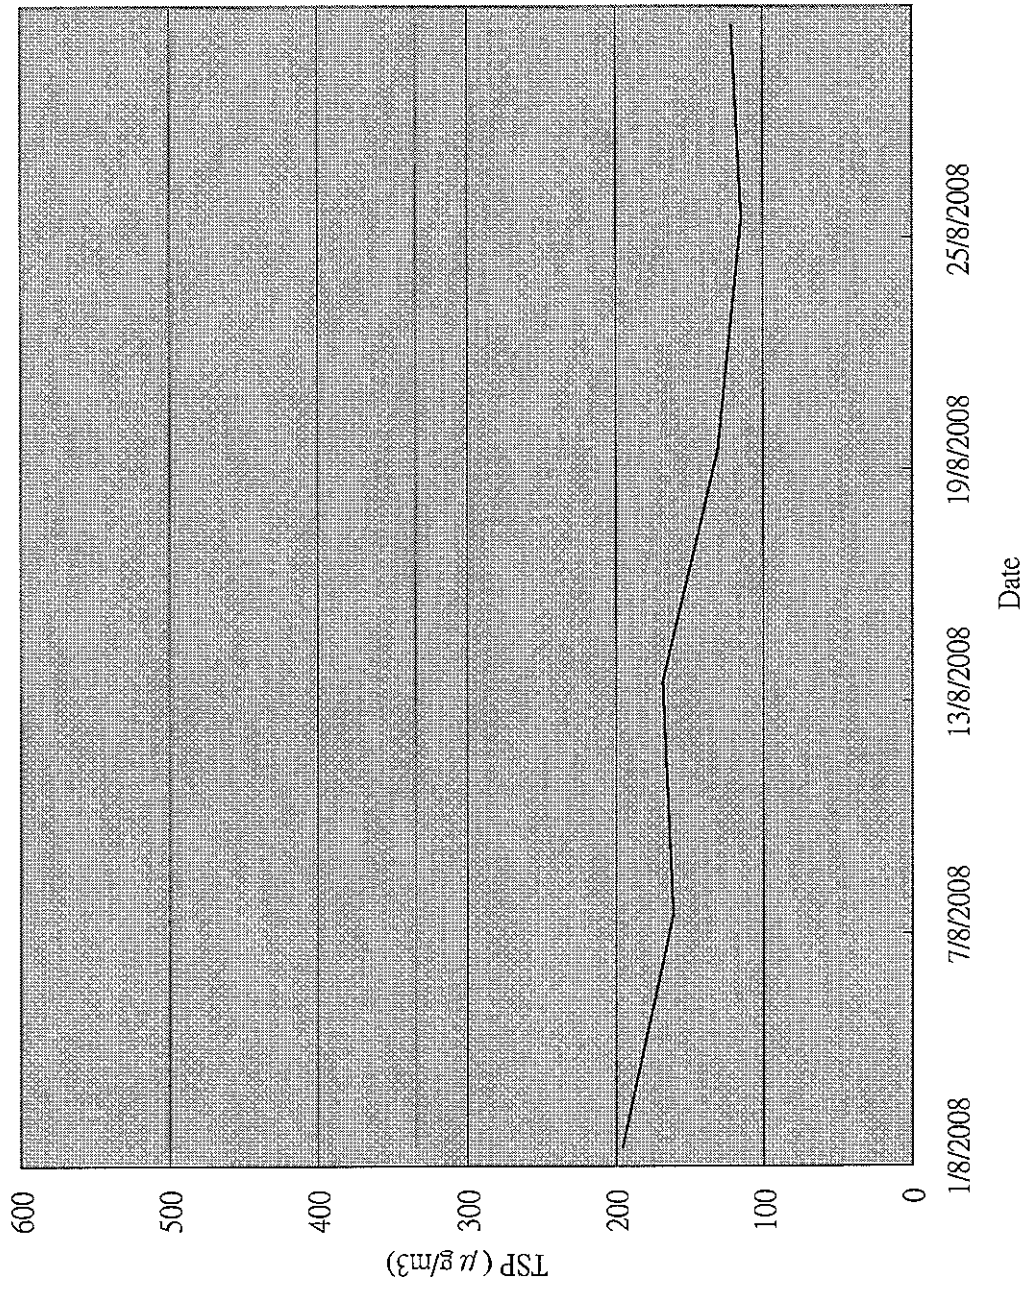
1-hour and 24-hour TSP monitoring results are summarized in Table 9 and 10 and serve as the basis for determining the action and limit levels. The minimum and maximum 1-hour TSP measured at Yuet Wu Villa was $107\mu\text{g}/\text{m}^3$ and $206\mu\text{g}/\text{m}^3$ respectively with an average of $149\mu\text{g}/\text{m}^3$. The minimum and maximum 24-hour TSP measured was $74\mu\text{g}/\text{m}^3$ and $94\mu\text{g}/\text{m}^3$ respectively with an average of $85\mu\text{g}/\text{m}^3$. Summary of air quality monitoring record is provided in Appendices C and D.

— Average 1-Hour TSP Monitoring Record
— Limit Level
— Action level

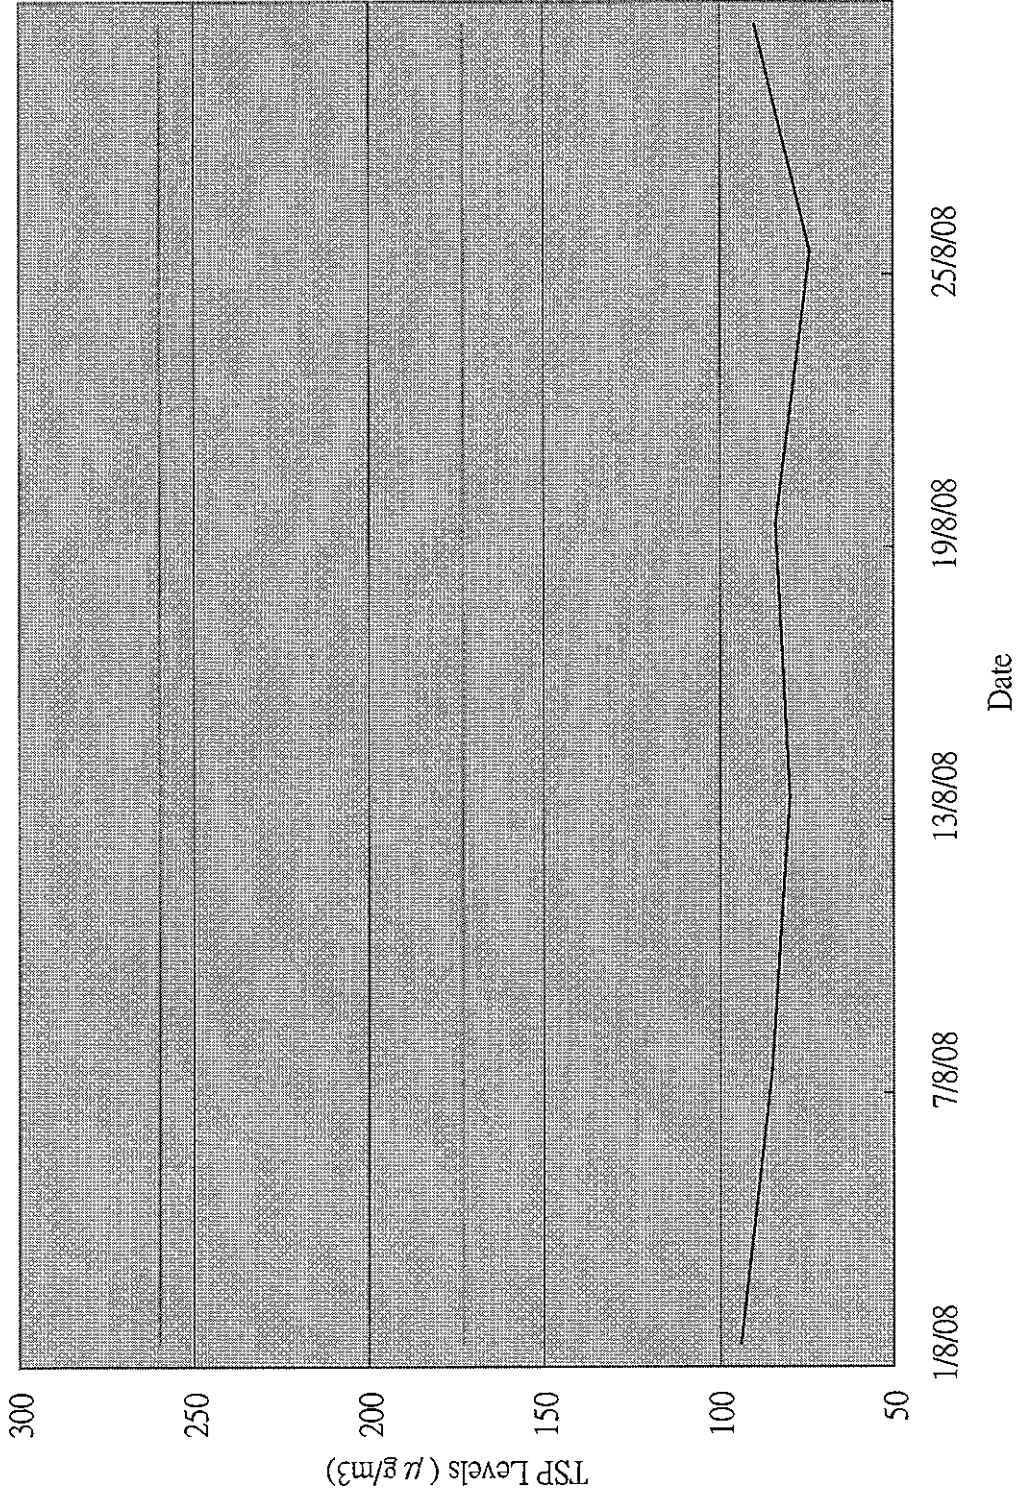
24-Hour TSP Monitoring Record

— 24-Hour TSP Levels
— Action level
- - - Limit Level

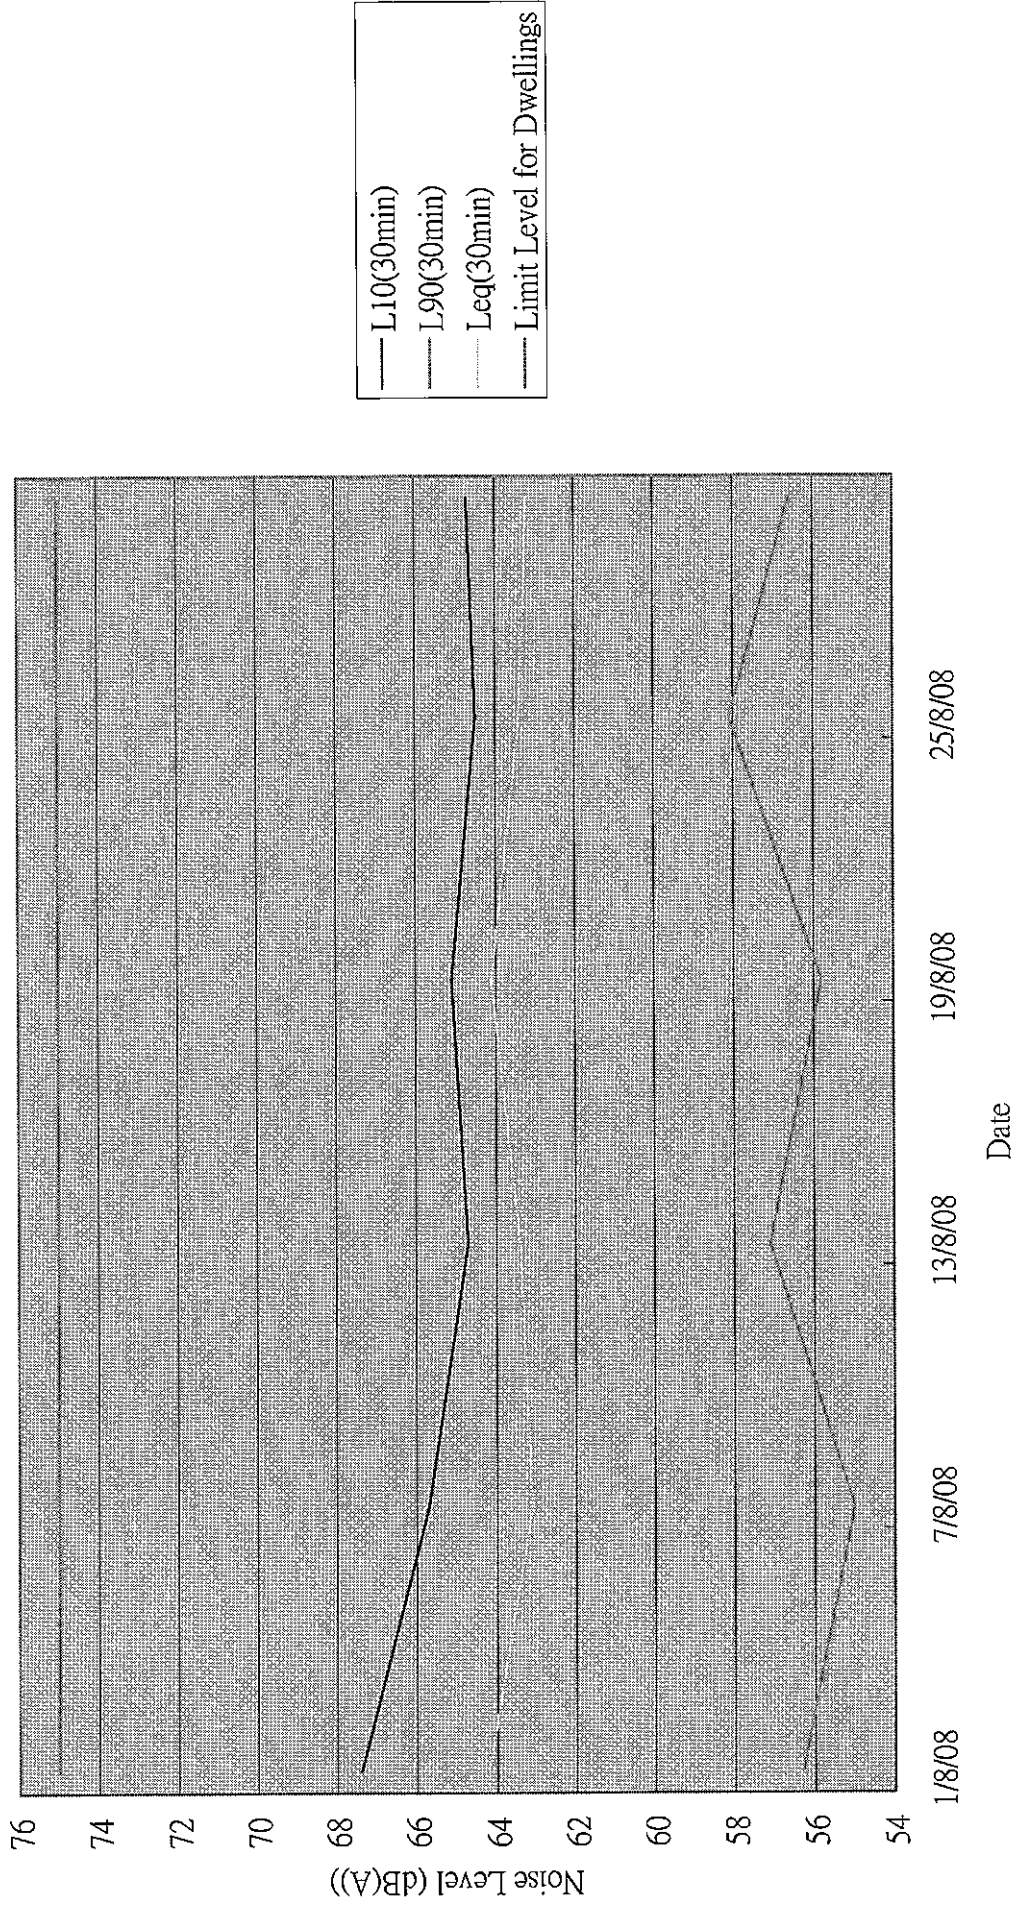
Graphical Plot of Noise Monitoring Record

During the reporting month, the minimum and maximum noise level measured at Yuet Wu Villa was 63.1dB(A) $L_{\text{eq}(30\text{min})}$ and 64.2dB(A) $L_{\text{eq}(30\text{min})}$ respectively with an average of 63.6dB(A) $L_{\text{eq}(30\text{min})}$. No exceedance was recorded in this reporting period. Summary of noise monitoring record is provided in Appendix E.

— L10(30min)
— L90(30min)
... Leq(30min)
— Limit Level for Dwellings
