**JOINT USER COMPLEX AND  
WHOLESALE FISH MARKET AT  
AREA 44, TUEN MUN**

**ENVIRONMENTAL MONITORING &  
AUDIT REPORT (JANUARY 2010)**

**ALLIED ENVIRONMENTAL CONSULTANTS LTD.**

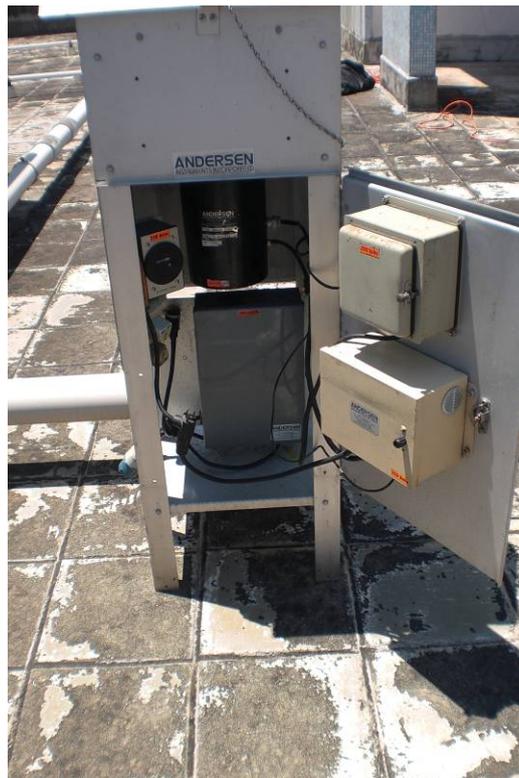
4

1-hour and 24-hour TSP air quality monitoring was conducted at the designated air quality monitoring location using a High Volume TSP Sampler (Model No: Anderson GMWS-2310 ACCU-VOL) at the designated location. The Calibration Record of the High-Volume TSP Sampler is given in Appendix B. 24-hour TSP samples were taken every six days. 1-hour TSP samples were taken three times a day between 0700-1900 hours. The weighing of the filter paper used in the monitoring will be undertaken by ALS Laboratory Group Environmental Division. (HOKLAS Registration No.: 066)

*Roof top of Block 15, Yuet Wu Villa*

*High-Volume Dust Sampler*

**JOINT USER COMPLEX AND WHOLESALE FISH MARKET AT AREA 44,  
TUEN MUN  
PHOTOS OF AIR QUALITY MONITORING STATION**

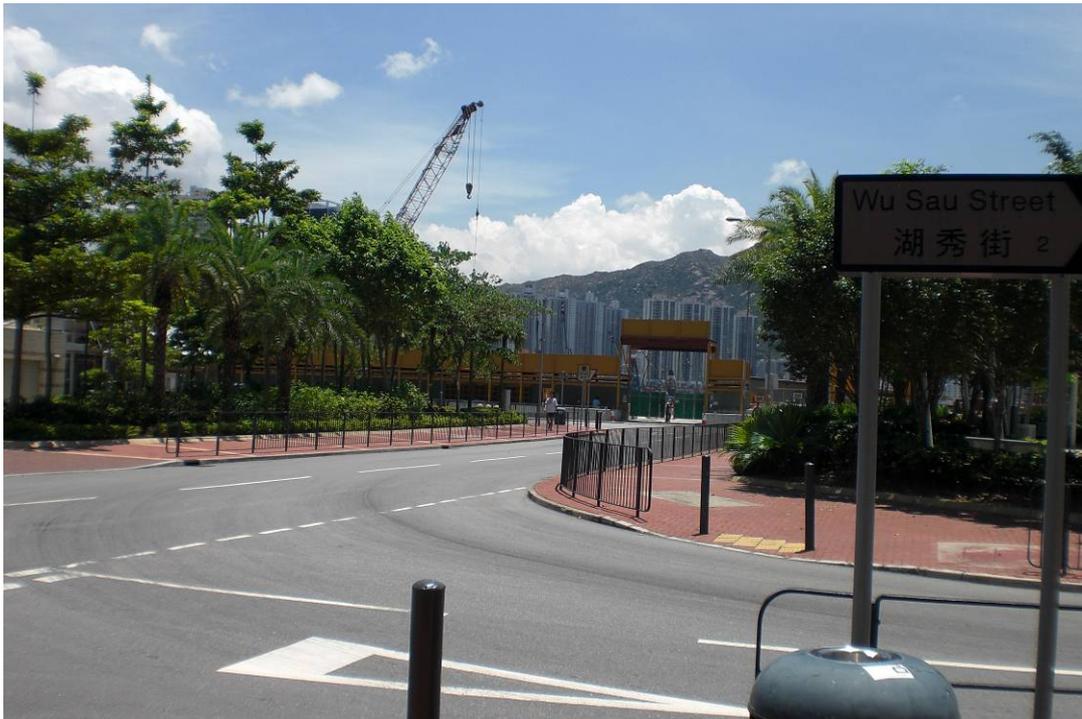
Figure No.	Rev.:
5	0
Scale	Date
NTS	2/10

on a tripod at a height of 1.2m and the microphone was positioned at 1m away the building façade of the noise monitoring station facing the construction site.

*Noise monitoring station*

*View from the noise monitoring station*

**JOINT USER COMPLEX AND WHOLESALE FISH MARKET AT AREA 44,  
TUEN MUN  
PHOTOS OF NOISE MONITORING STATION**

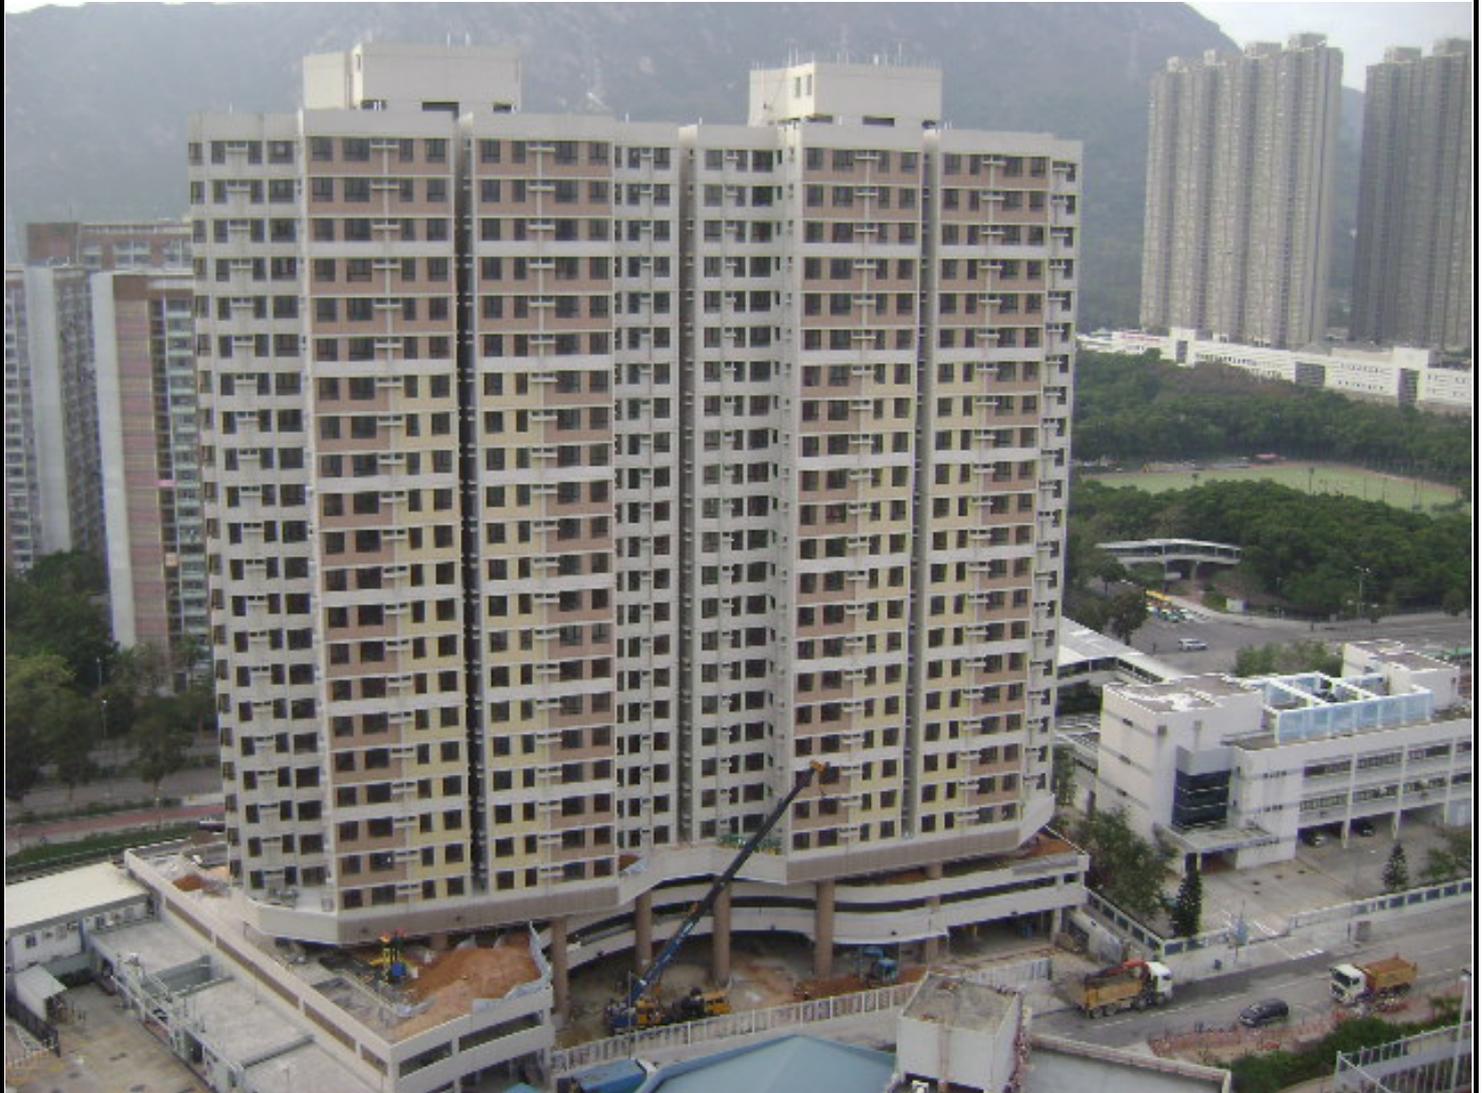
A construction site for the proposed Junior Police Officers' Married Quarters is located at Wu Hong Street which is 110m away from the monitoring location, which can be a major source of the noise and TSP generation during the monitoring period. Figure 6 shows the photo of the construction site.

**PHOTO OF CONSTRUCTION SITE FOR JUNIOR POLICE OFFICERS' MARRIED QUARTERS**
