**JOINT USER COMPLEX AND
WHOLESALE FISH MARKET AT
AREA 44, TUEN MUN**

**THIRD QUARTERLY
ENVIRONMENTAL MONITORING &
AUDIT REPORT
(FEBRUARY 2009 – APRIL 2009)**

ALLIED ENVIRONMENTAL CONSULTANTS LTD.

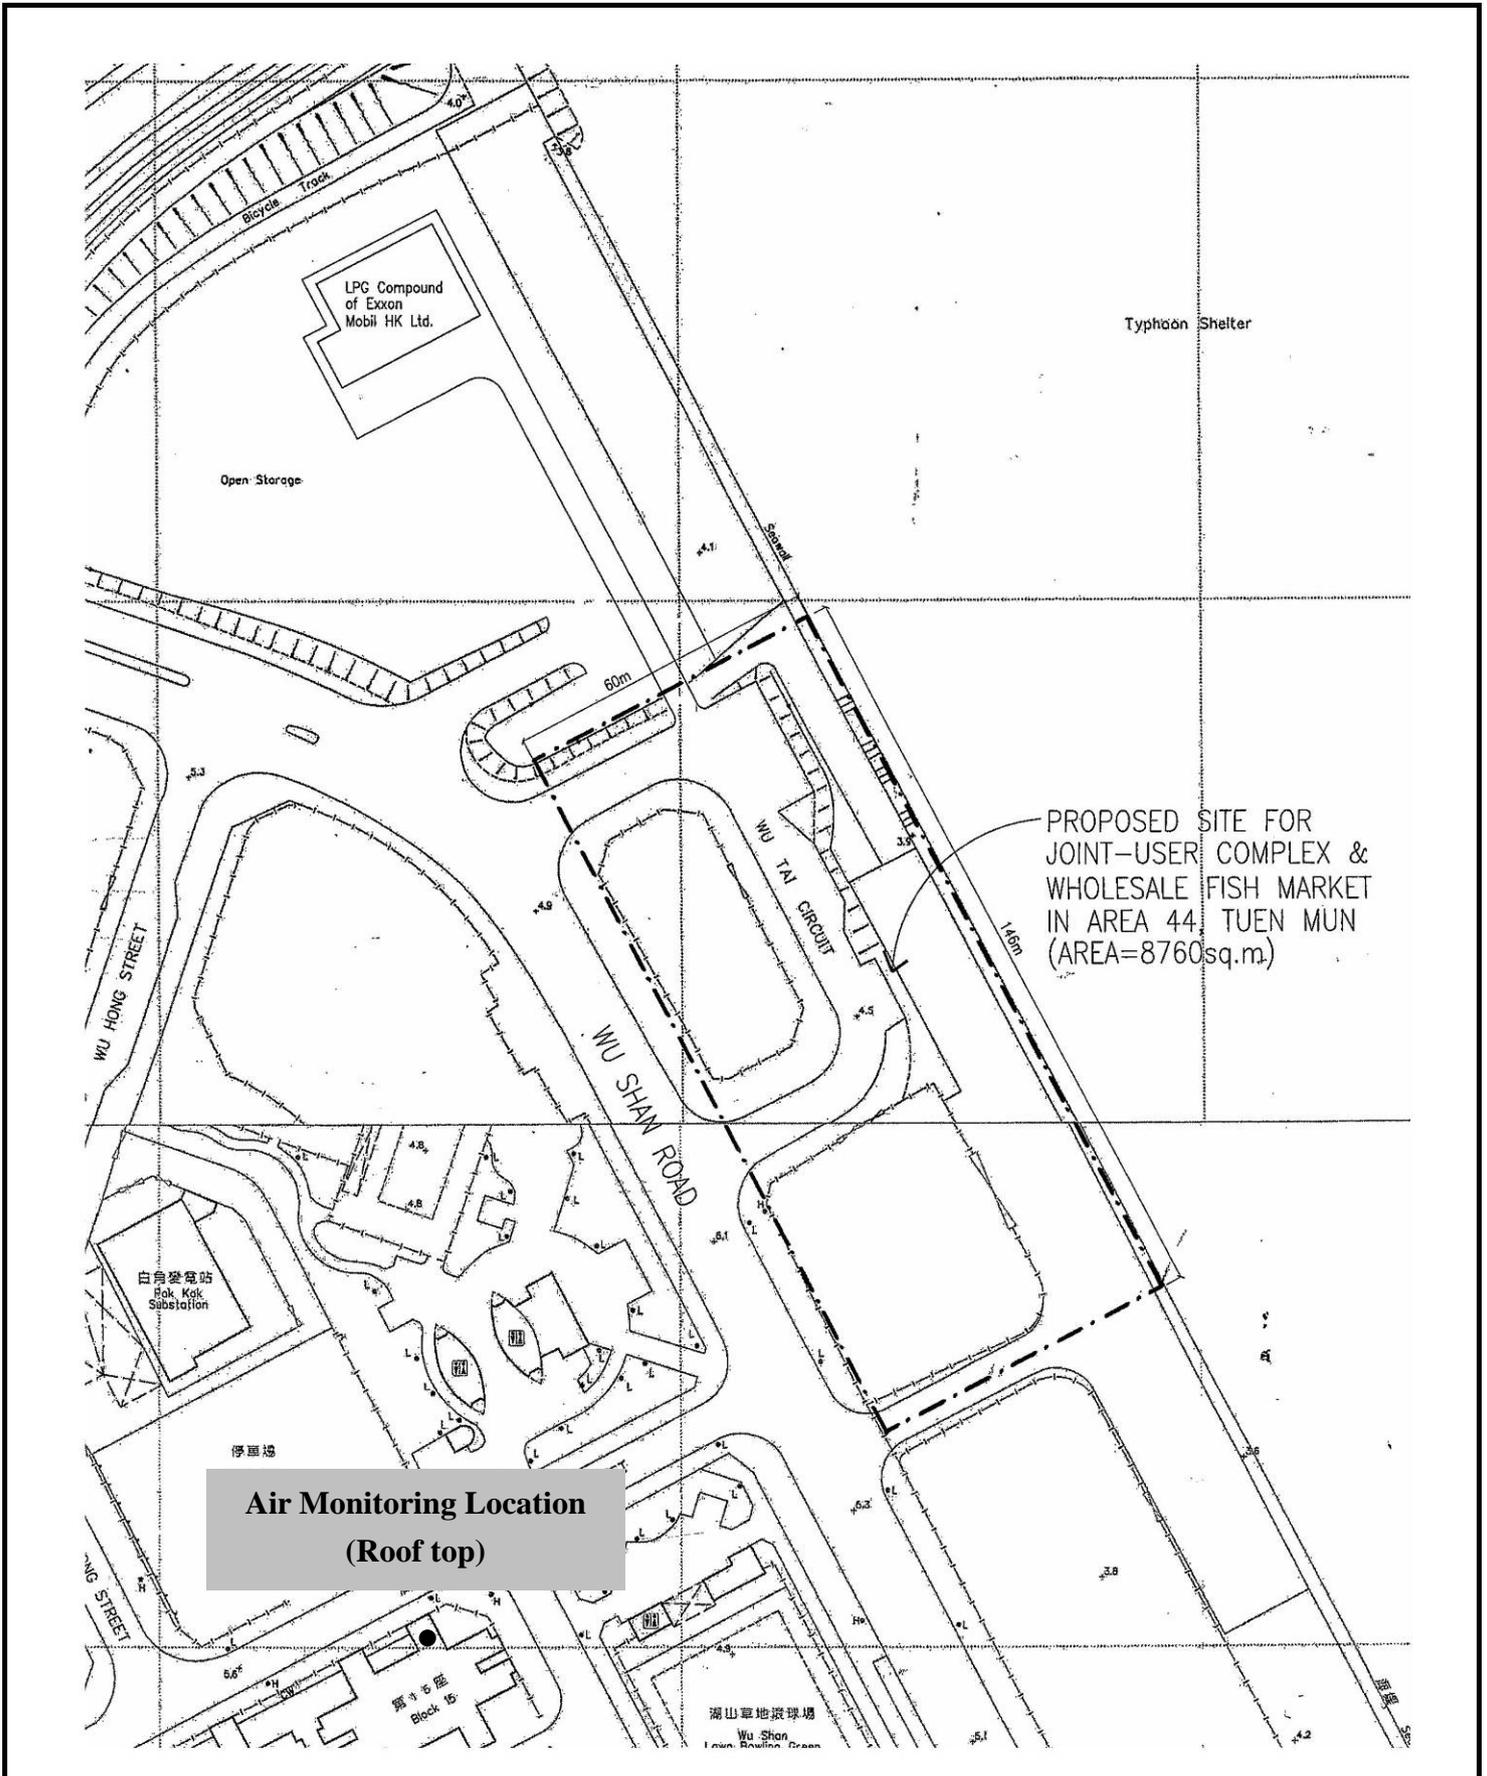
Figure No.	Rev.:
2	0
Scale	Date
NTS	5/09

Air quality monitoring and noise monitoring were conducted at Block 15, Yuet Wu Villa. Air quality monitoring station was set up at the roof top of the residential block and noise monitoring was conducted at 1.2m above ground level at the junction of Wu Sau Street and Wu On Street as given in Figure 2 and 3. Figure 4 and 5 show photos taken during monitoring at the two locations.

LOCATION OF AIR QUALITY MONITORING STATION

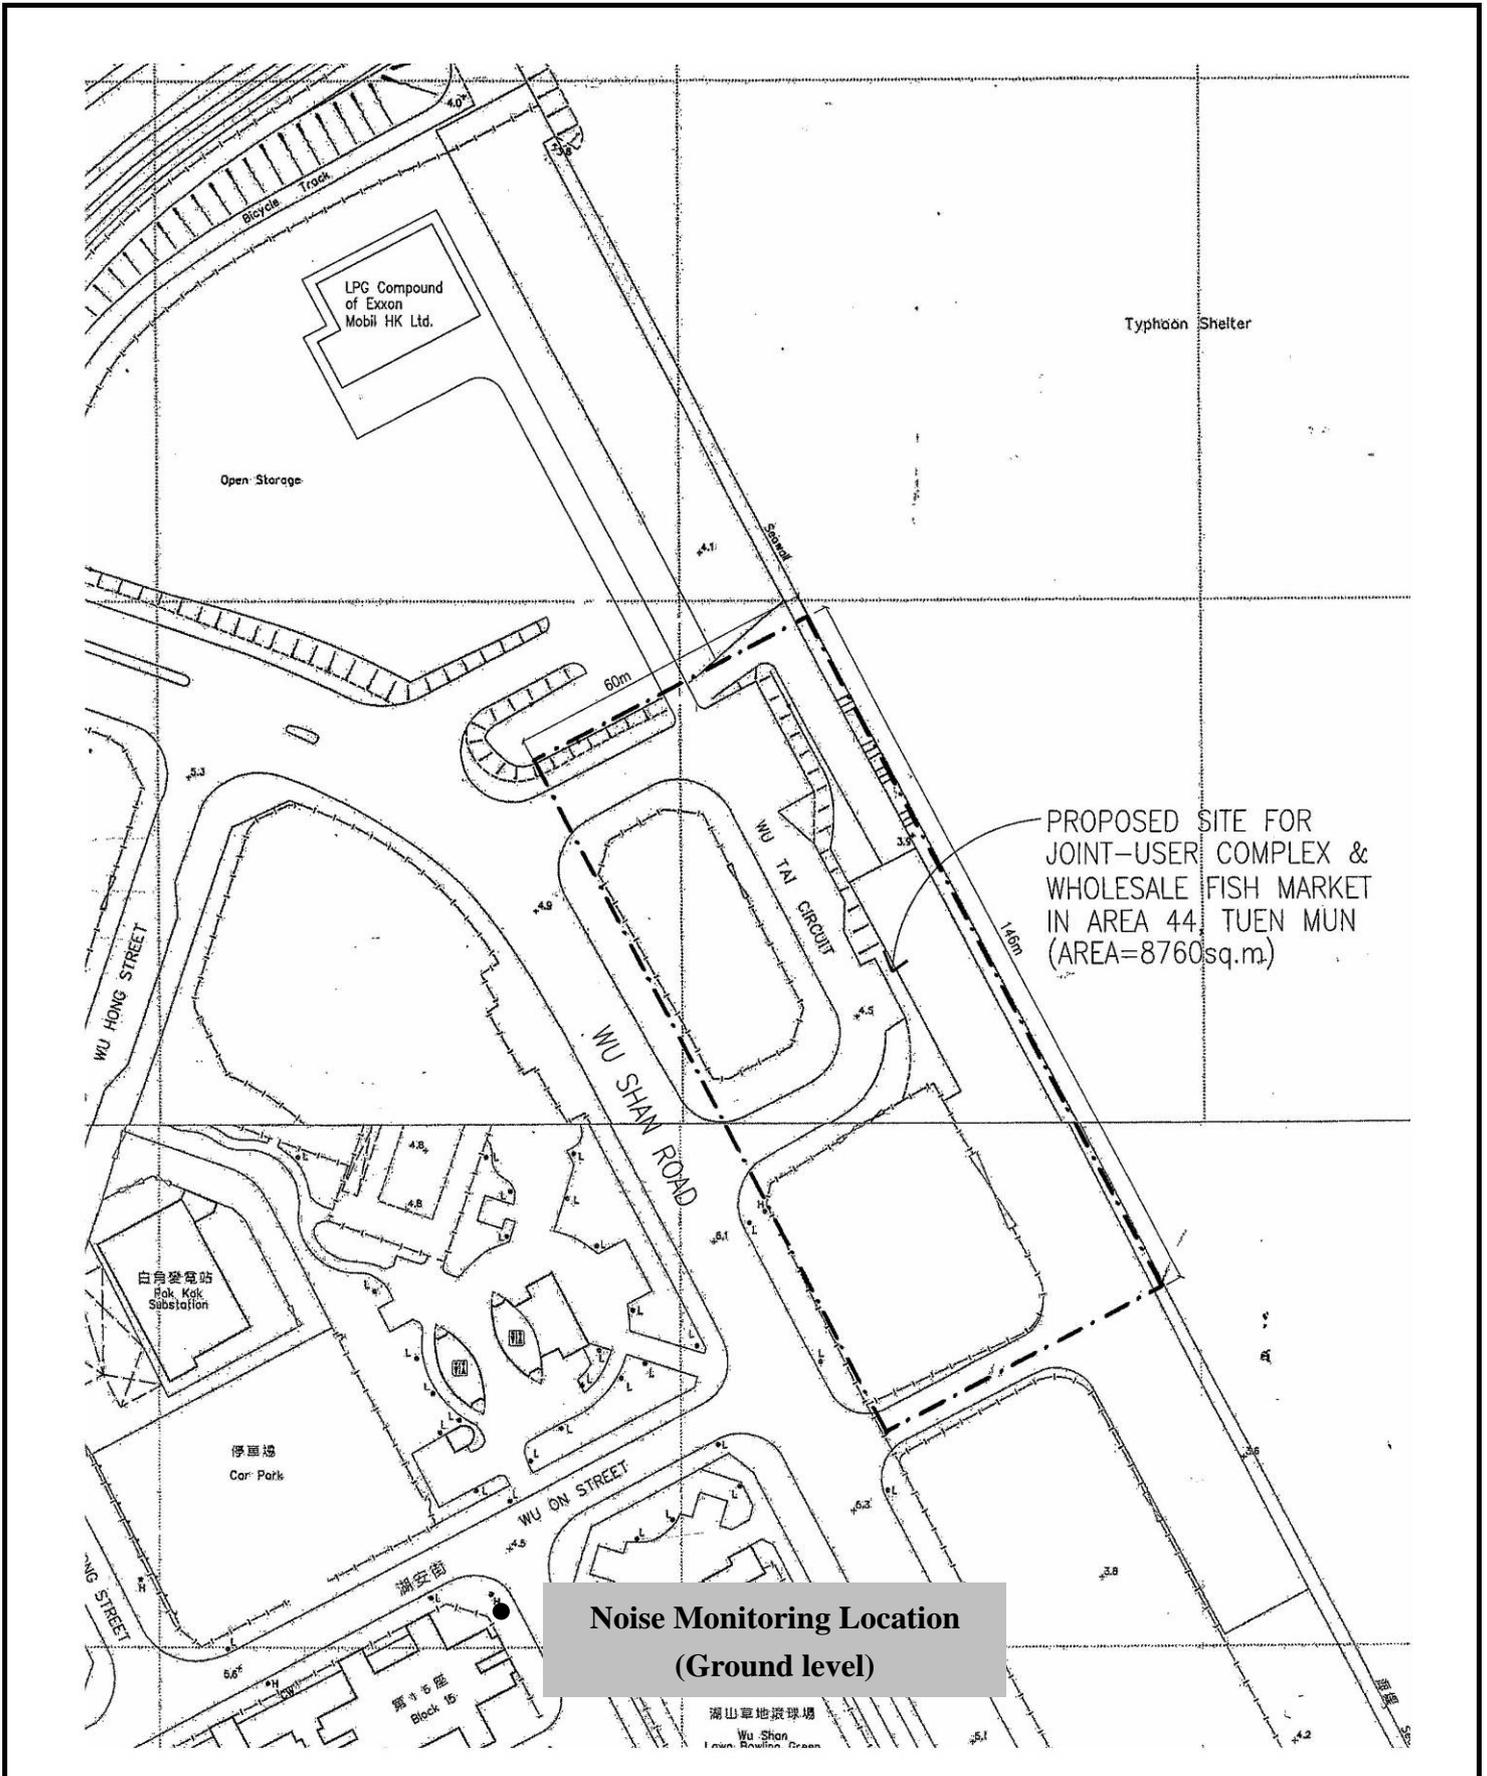
Figure No.	Rev.:
3	0
Scale	Date
NTS	5/09

**JOINT USER COMPLEX AND WHOLESALE FISH MARKET AT AREA 44,
TUEN MUN
LOCATION OF NOISE MONITORING STATION**

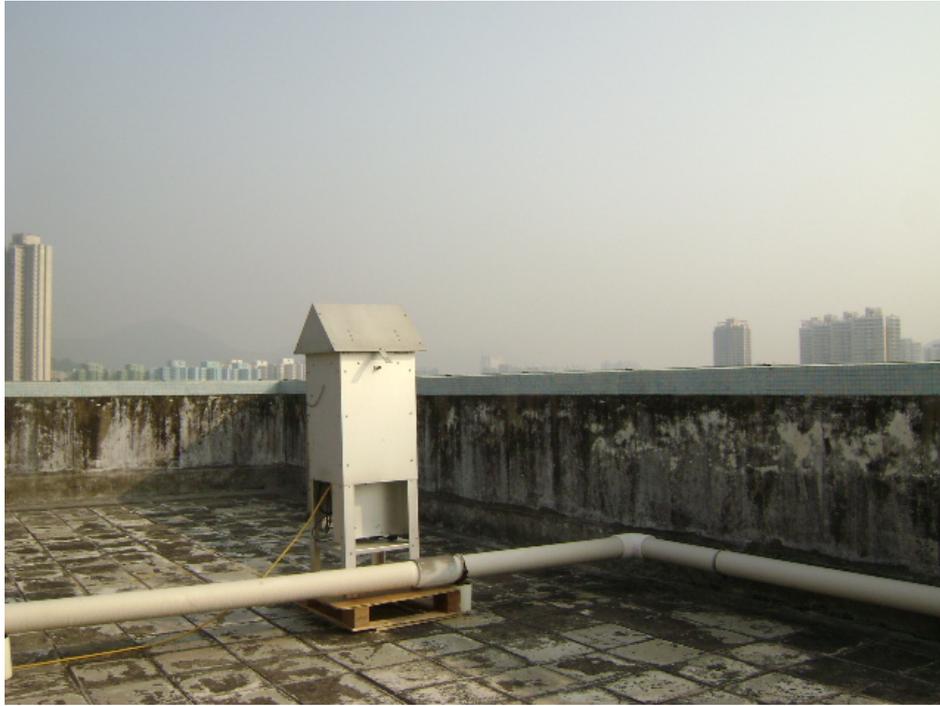
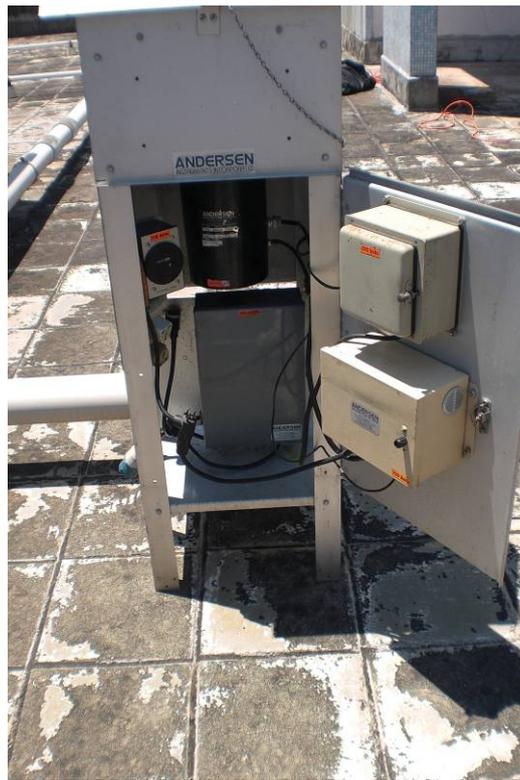
Figure No.

1-hour and 24-hour TSP air quality monitoring was conducted at the designated air quality monitoring location using a High Volume TSP Sampler (Model No: Anderson GMWS-2310 ACCU-VOL) at the designated location. The Calibration Record of the High-Volume TSP Sampler is given in Appendix A. 24-hour TSP samples were taken every six days. 1-hour TSP samples were taken three times a day between 0700-1900 hours.

Roof top of Block 15, Yuet Wu Villa

High-Volume Dust Sampler

**JOINT USER COMPLEX AND WHOLESALE FISH MARKET AT AREA 44,
TUEN MUN
PHOTOS OF AIR QUALITY MONITORING STATION**

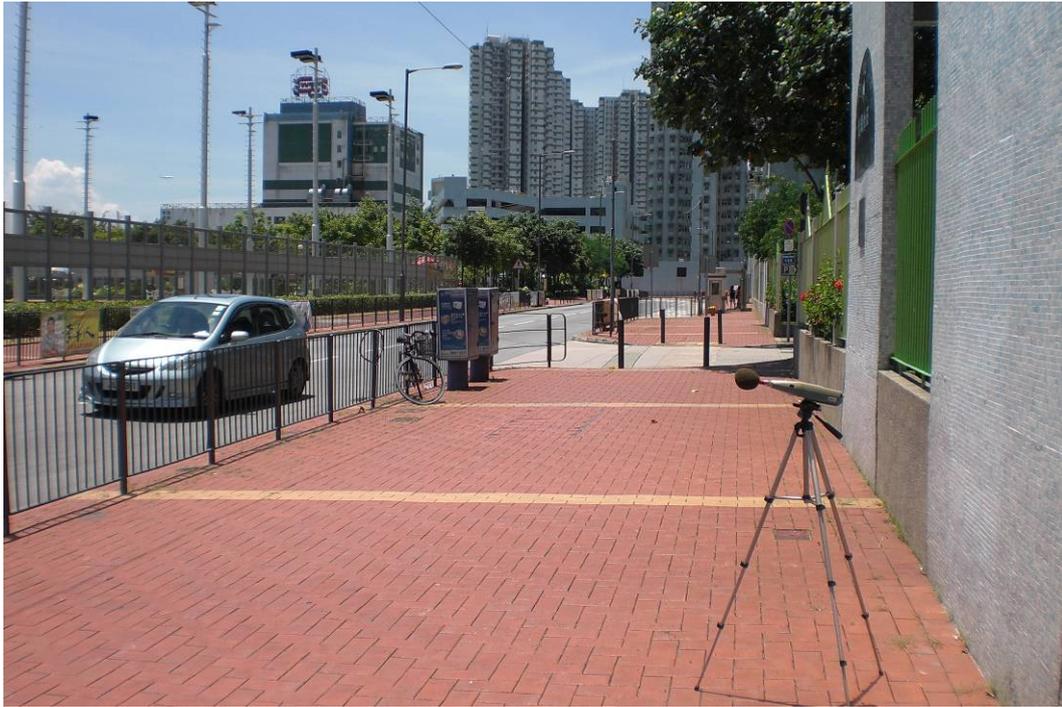
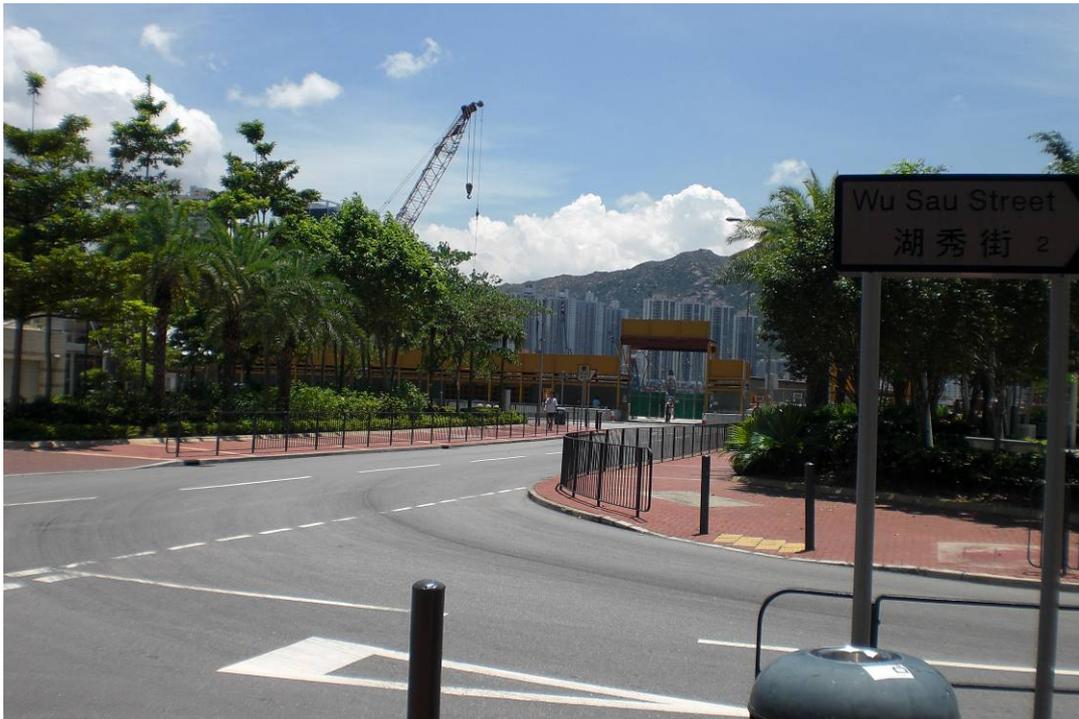
Figure No.

Noise levels measurements were recorded in terms of thirty minutes A-weighted equivalent continuous sound pressure level ($L_{eq}(30min)$) on a weekly basis. The sound level meter was calibrated immediately prior to and following each noise measurement. The meter was mounted on a tripod at a height of 1.2m and the microphone was positioned at 1m away the building façade of the noise monitoring station facing the construction site.

Noise monitoring station

View from the noise monitoring station

**JOINT USER COMPLEX AND WHOLESALE FISH MARKET AT AREA 44,
TUEN MUN
PHOTOS OF NOISE MONITORING STATION**

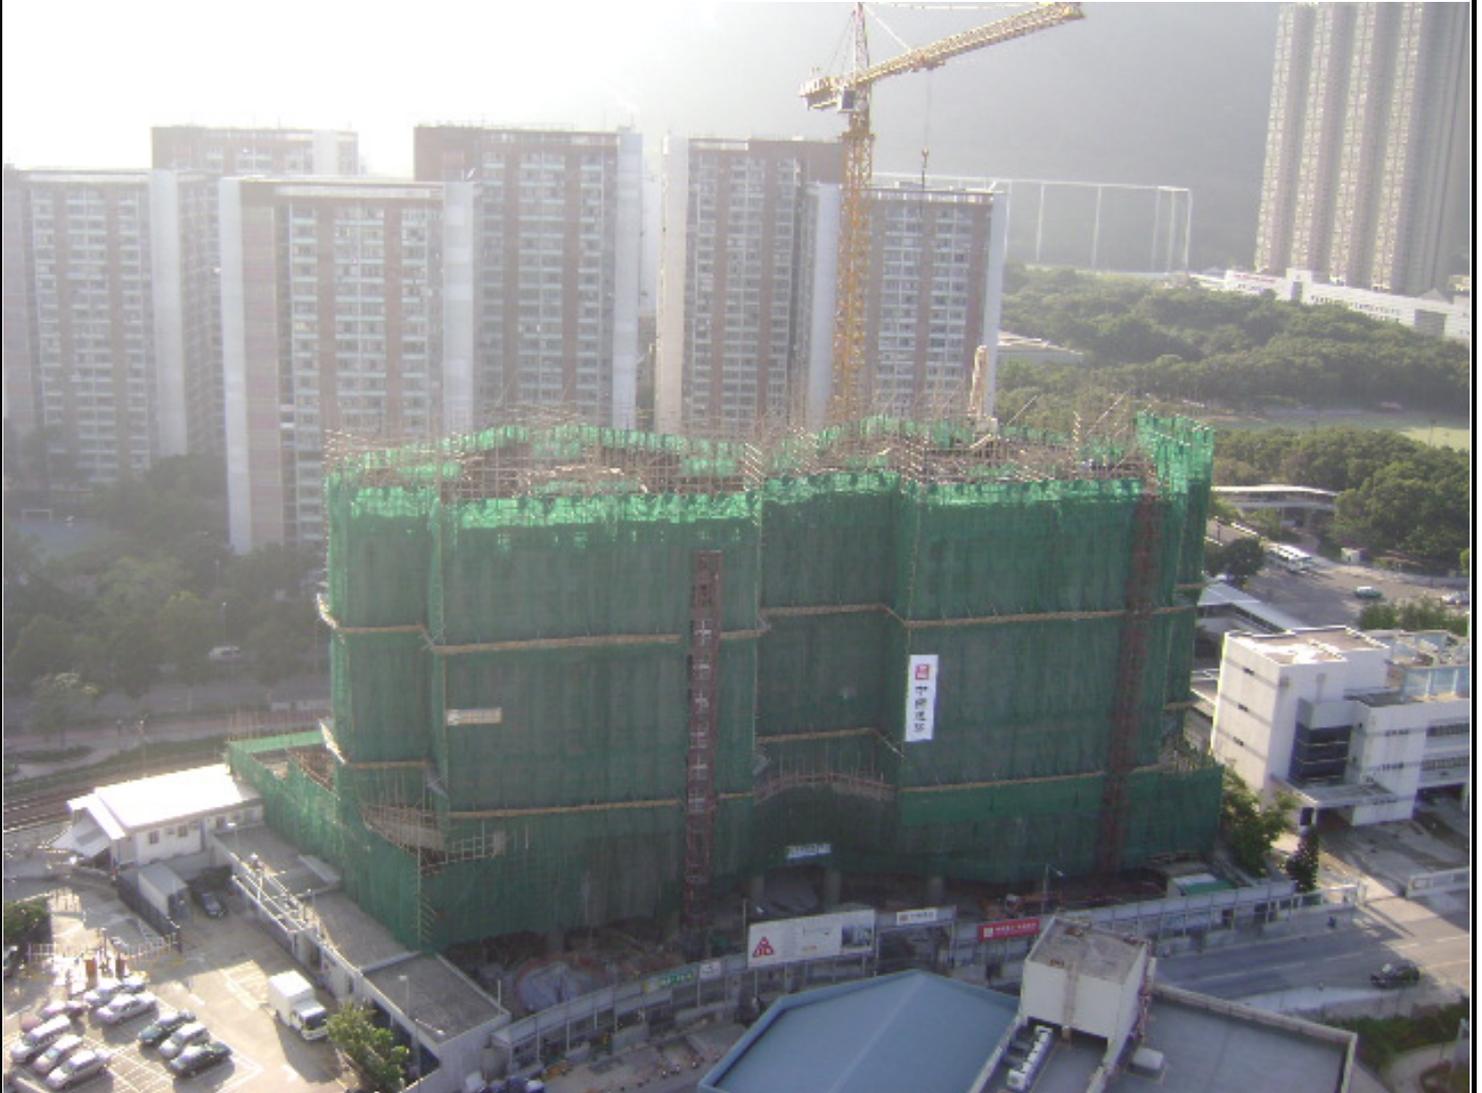
Figure No.

A construction site for the proposed Junior Police Officers' Married Quarters is located at Wu Hong Street which is 110m northwest from the monitoring location, which is also a potential major source of the TSP generation. Figure 6 shows the photos of the construction site.

PHOTO OF CONSTRUCTION SITE FOR JUNIOR POLICE OFFICERS' MARRIED QUARTERS

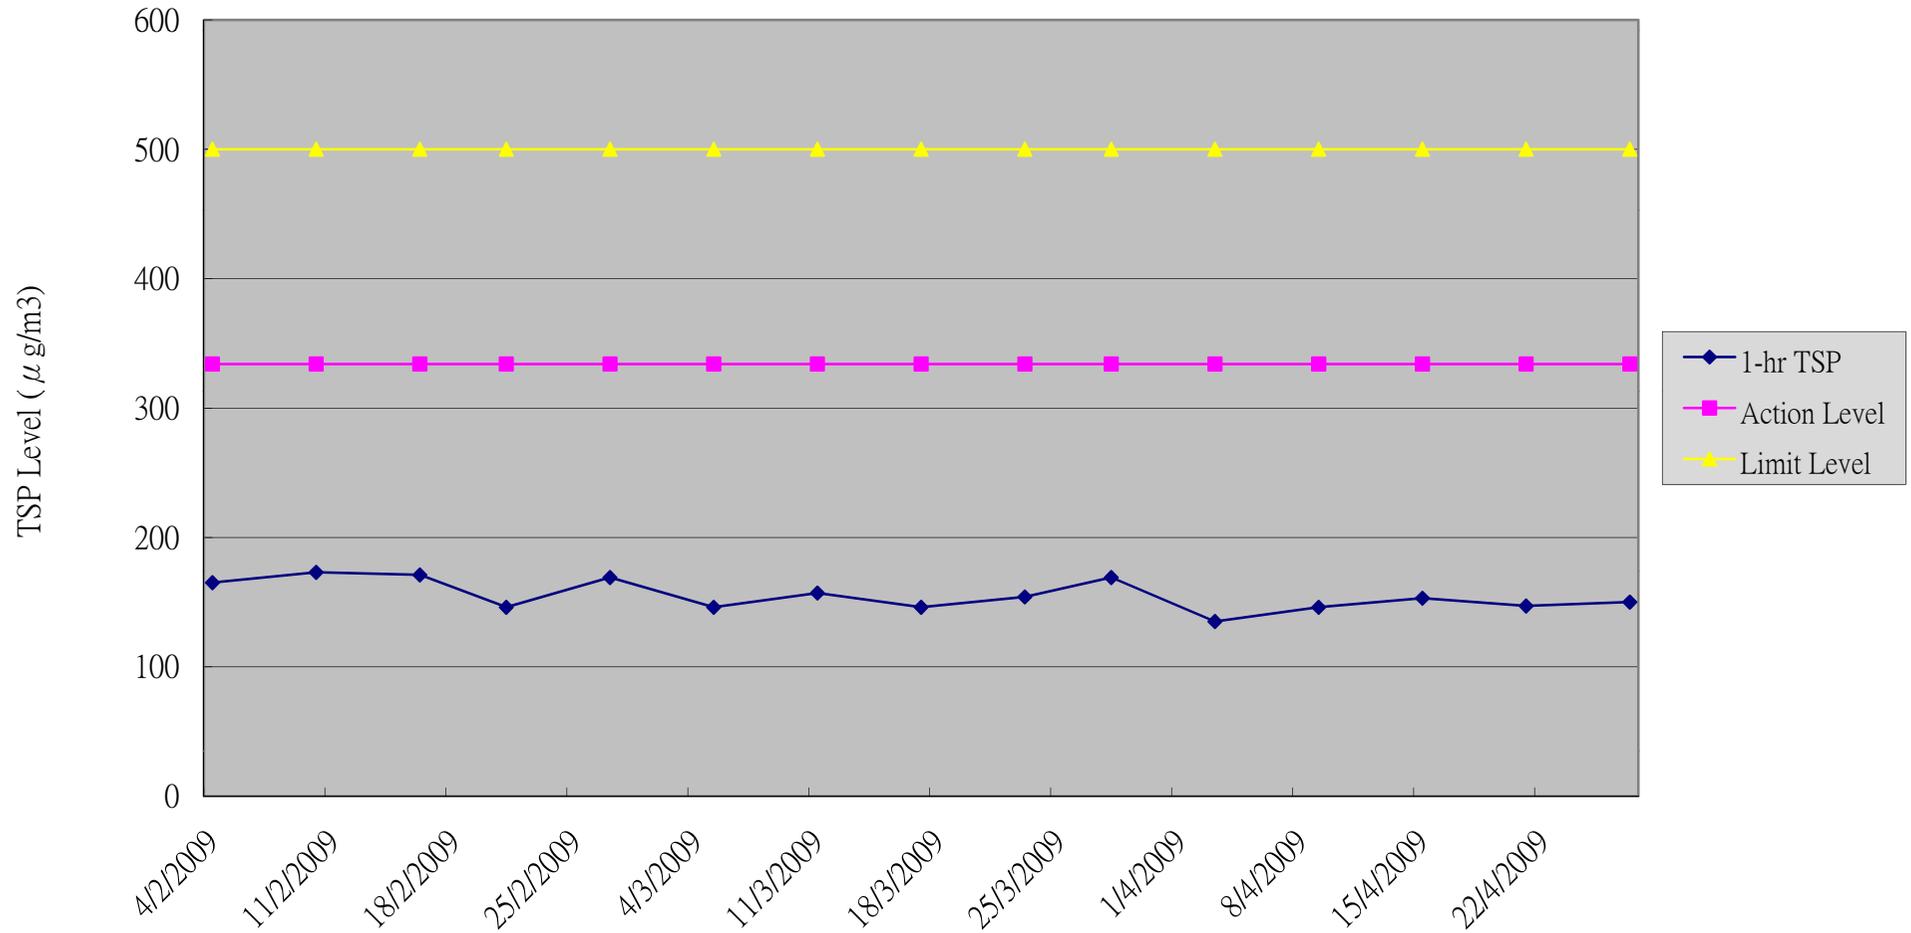
1-hr TSP Levels (February 2009 - April 2009)

No exceedance was recorded in this quarter. Summary and graphical plots of air quality monitoring record of 1-hour TSP levels and 24-hour TSP levels are provided in Appendices C and D.

Date	Time	1-hr TSP ($\mu\text{g}/\text{m}^3$)	Average
4-Feb-09	08:40 - 09:40	147	165
	09:40 - 10:40	171	
	10:40 - 11:40	178	
10-Feb-09	08:40 - 09:40	147	173

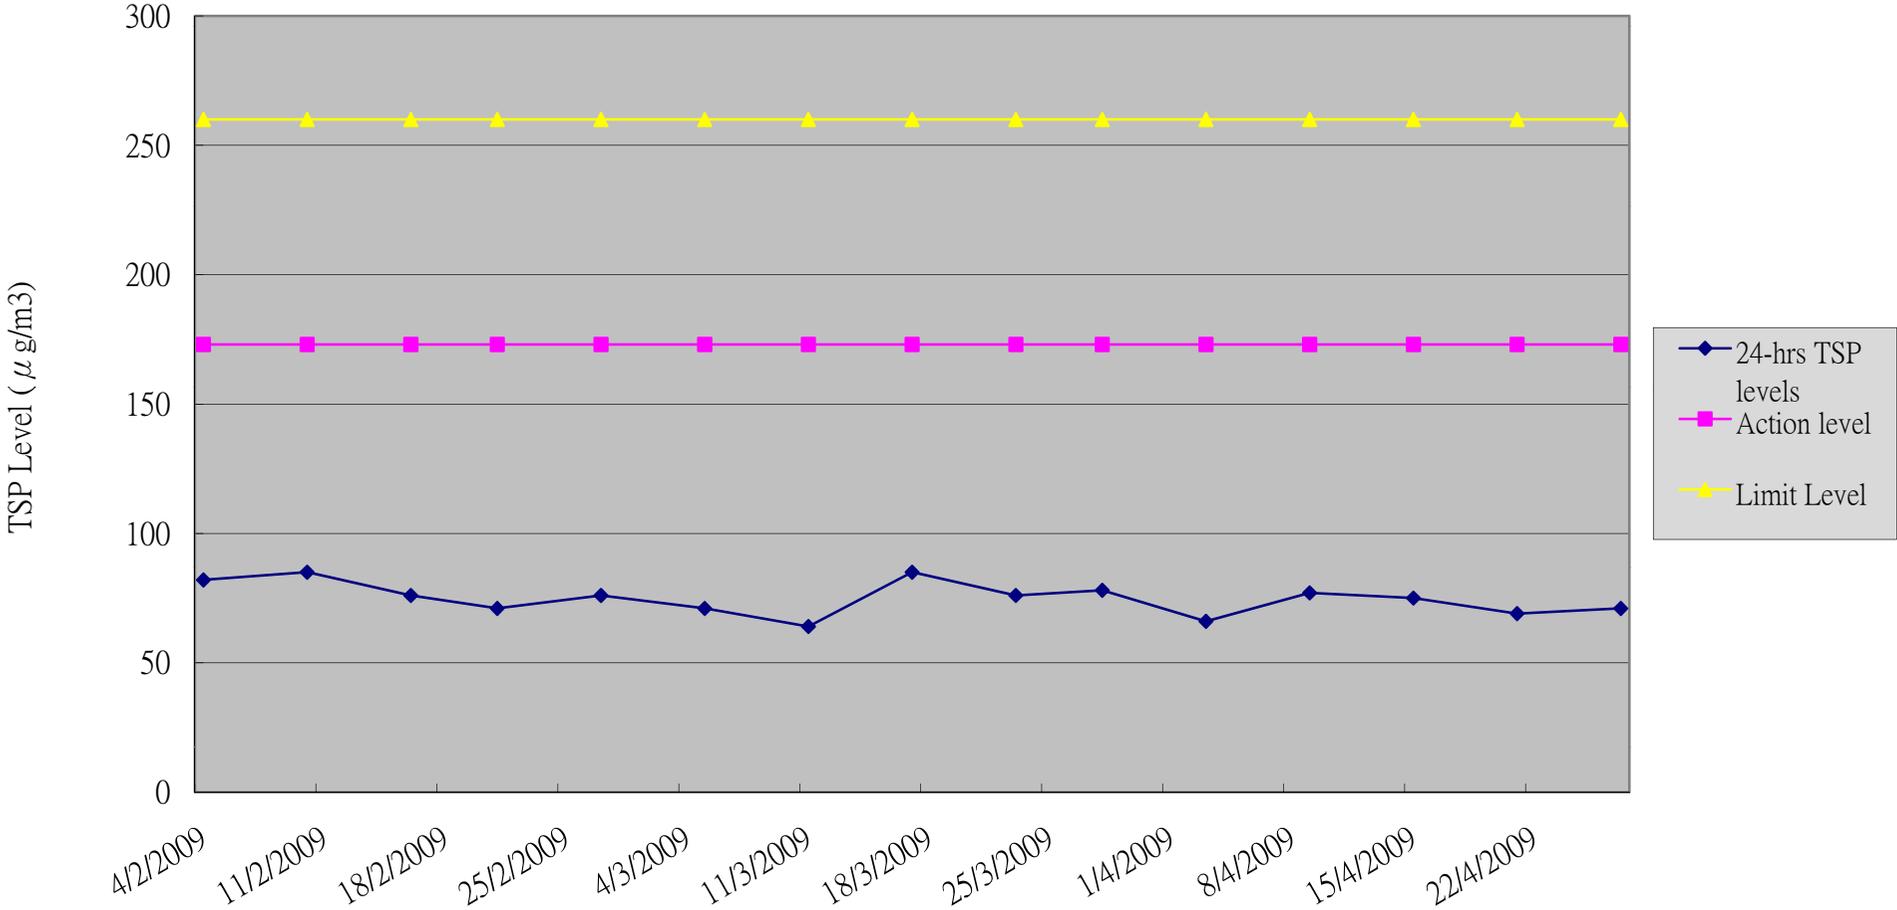
24-hour TSP Levels

Date	Start time	24-hr TSP ($\mu\text{g}/\text{m}^3$)
4-Feb-09	11:40	82
10-Feb-09	11:40	85
16-Feb-09	11:50	76
21-Feb-09	11:40	71
27-Feb-09	11:40	76
5-Mar-09	11:40	71
11-Mar-09	11:40	64
17-Mar-09	11:40	85
23-Mar-09	11:50	76
28-Mar-09	11:40	78
3-Apr-09	11:40	66
9-Apr-09	11:45	77
15-Apr-09	11:40	75
21-Apr-09	11:40	69
27-Apr-09	11:40	71

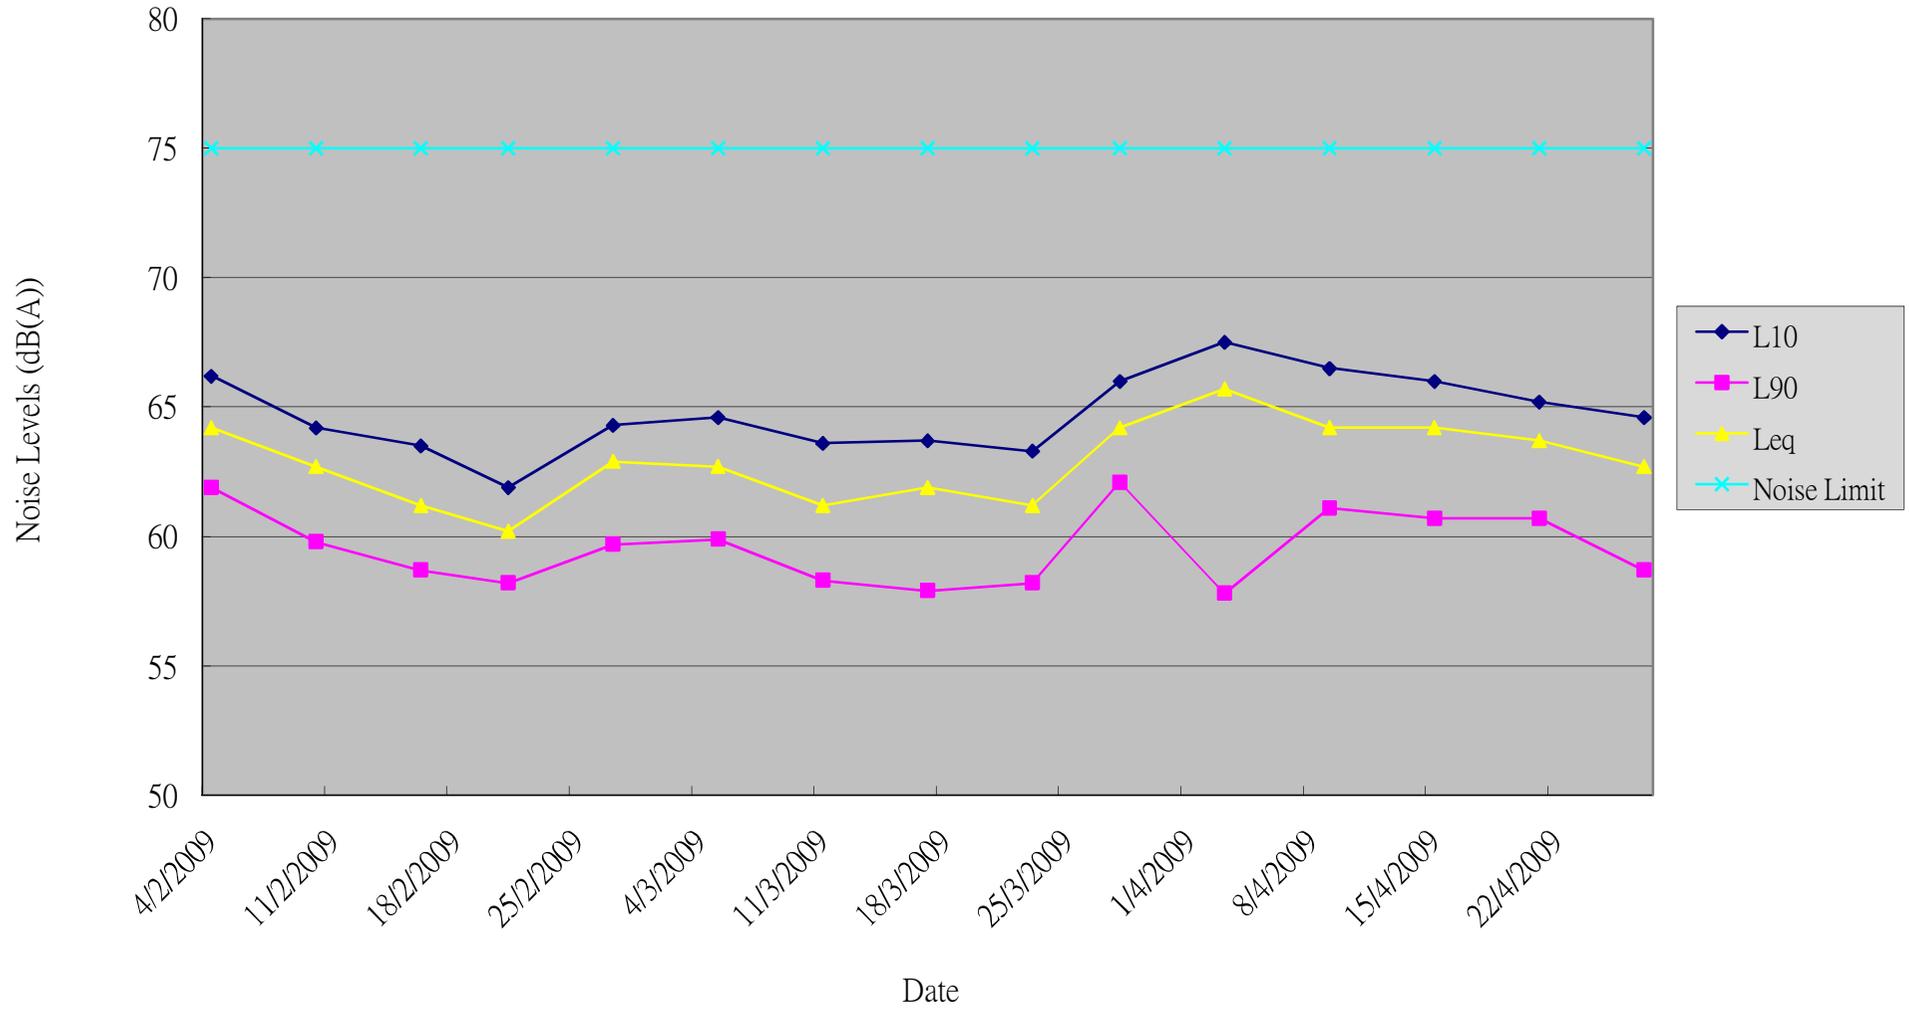
Noise Monitoring Record (February 2009 - April 2009)

No exceedance was recorded in this quarter. Summary of noise monitoring record is provided in Appendix E.

Date	Time	L10(30mins) (dB(A))	L90(30mins) (dB(A))	Leq(30mins) (dB(A))
4-Feb-09	09:05 - 09:35	66.2	61.9	64.2
10-Feb-09	08:50 - 09:20	64.2	59.8	62.7
16-Feb-09	09:00 - 09:30	63.5	58.7	61.2
21-Feb-09	09:00 - 09:30	61.9	58.2	60.2
27-Feb-09	09:05 - 09:35	64.3	59.7	62.9
5-Mar-09	09:00 - 09:30	64.6	59.9	62.7
11-Mar-09	09:00 - 09:30	63.6	58.3	61.2
17-Mar-09	09:00 - 09:30	63.7	57.9	61.9
23-Mar-09	09:00 - 09:30	63.3	58.2	61.2
28-Mar-09	09:00 - 09:30	66	62.1	64.2
3-Apr-09	09:00 - 09:30	67.5	57.8	65.7
9-Apr-09	09:00 - 09:30	66.5	61.1	64.2
15-Apr-09	09:00 - 09:30	66	60.7	64.2
21-Apr-09	09:00 - 09:30	65.2	60.7	63.7
27-Apr-09	09:00 - 09:30	64.6	58.7	62.7
